## Experimental Investigation and Failure Analysis of Pivot Head in WAG-9 Locomotive

S.V. Pawade<sup>1</sup>, Dr. R. N. Baxi<sup>2</sup>

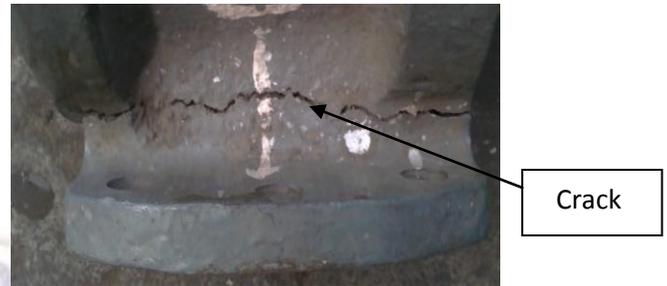
Figure4: Failure Component

This Pivot Head material is made up of cast steel (DIN 17182 GS 20Mn 5) [2]. In this proposed study the failure investigation of the crack formed at curvature of the flange region ("Fig.4") and premature failure of the Pivot Head is discussed in details.

Crack

It is reported that cracks were found at the curvature of flange in Pivot Head. For detail investigation of this crack, Ultrasonic test was carried out.

It is reported that cracks were found in pivot head at a distance of 70 & 72 mm from scanning surface (entire surface representing curvature of the flange).

It is therefore suggested that some suitable heat treatment will enhance the life of the Pivot Head. For the existing lot of the Pivot Head, homogenization anneal followed by the suitable cooling cycle will help in refinement of the grain size. This homogenized and refined grain structure will further increase the hardness value. The life of the Pivot Head thus will get increased to certain extent and the failure rate will get declined.

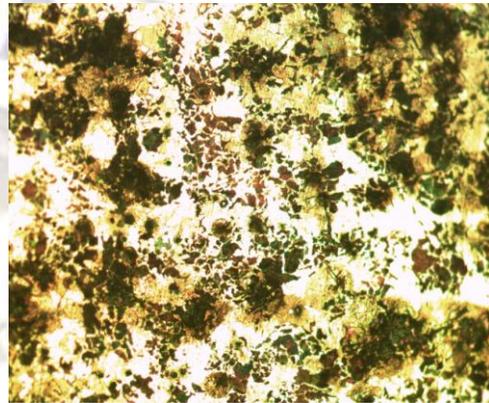
Figure:7 Metallograph of the failure component of the Pivot Head. X100.

From the "Fig.7", following observations are made:

1. Almost 50 % region in the microstructure shows Carbide phase ( $Fe_3C$ ) Iron Carbide and Alloy Carbide.
2. The metallographic analysis can be very well correlated with the chemistry of the component. The observation as per the microscopic examination gives clear-cut indication of higher carbon content in the material, although specified value of the carbon is 0.23%.
3. Coarse grain structure is observed.
4. Non-uniformity in overall grain size is observed.
