## Identification of Pathologies in Bridges Using Infrared Thermography

Lucas Moreira Gomides\*, Yuri Sotero Bomfim Fraga\*\*

\* Department of Civil Engineering, Euro-American University Center, Brazil

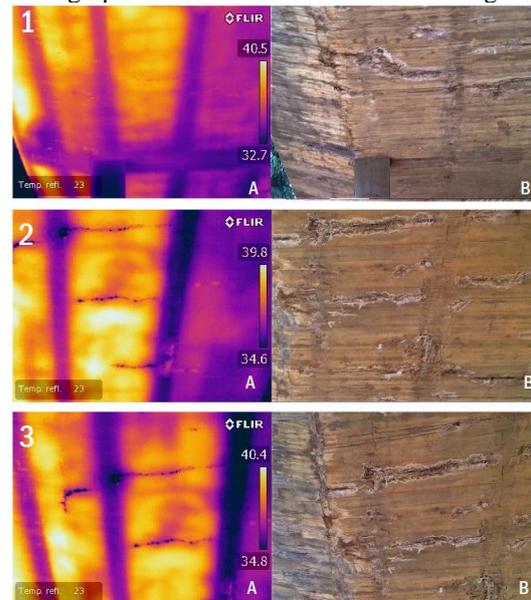
**Figure 1:** A) Thermographic photo of the sides of the bridge; B) Original photo of the sides of the bridge.

Through infrared thermography, it was possible to observe that in some of these regions the flaws may be evolving to greater damage to the structure, evidenced by the different coloring obtained in the thermogram. It is also possible to observe, through the images, points that show signs of carbonation.

Where the purple colors are most evident, they are very flawed areas subject to imminent displacement of the concrete. One of the causes of this displacement is the failure to maintain the bridge.

The corrosion found in the system is an evolutionary process, that is, over time it gets worse. In order to guarantee structural security, security measures cannot be taken too late.

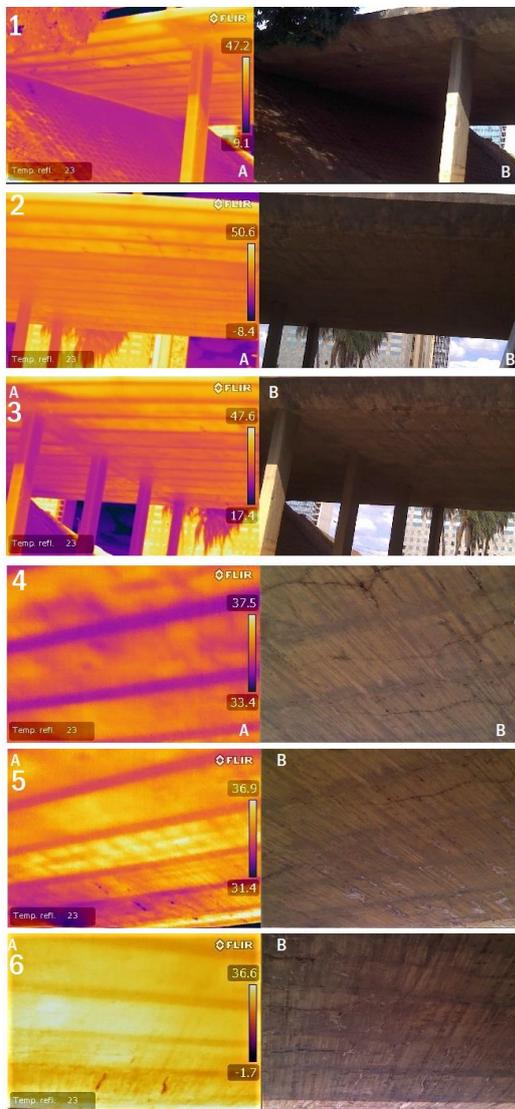
Fig. 2 shows pictures taken with the thermographic camera from the center of the bridge. It is possible to observe the presence of cracks and cracks with moisture due to the darker colors in the thermographic photos.

Through the cracks, water (H<sub>2</sub>O) enters the concrete structure, along with carbon dioxide (CO<sub>2</sub>). When the frame comes into contact with these two

elements, the corrosion process begins. When reinforcement corrodes, it expands within the concrete structure. With the expansion of reinforcement, the concrete structure cracks and consequently generates the detachment of pieces of concrete.

Figure 2: A) Thermographic photo of the center of the bridge; B) Original photo of the center of the bridge.

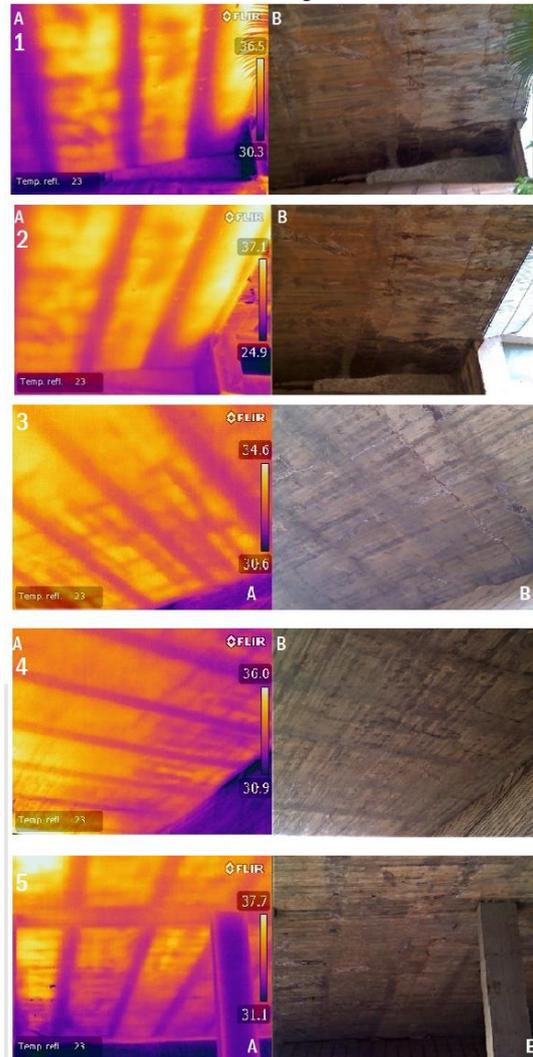
Figure 3: A) Thermographic photo of the end of the bridge; B) Original photo of the end of the bridge.

It is possible to observe in Fig. 3 an advanced state of reinforcement corrosion along the bridge, in areas that have moisture and infiltrations, causing concrete to crack.

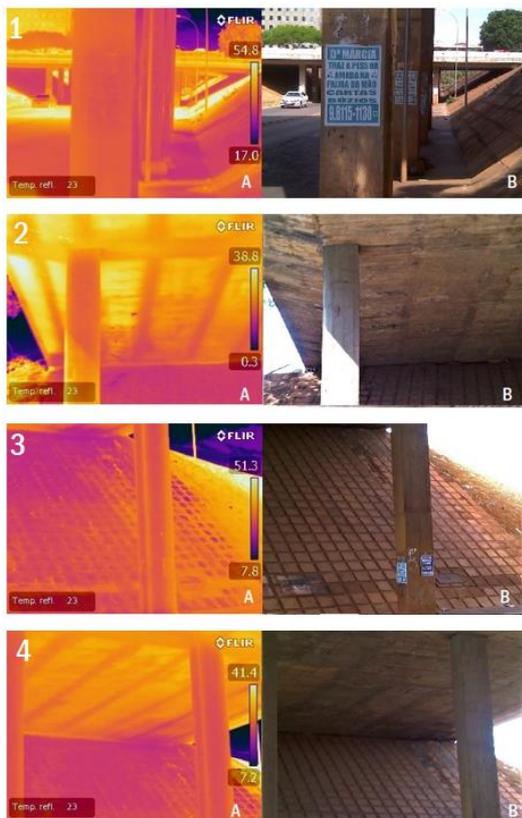
Fig. 4 presents photos taken with the thermographic camera of the bridge pillars. It can be seen that the bridge has no water seeping on its pillars. Analyzing the thermographic photos, the pillars do not show color variation in the thermography images, but a constant color in the incidence of heat, i.e., they do not have cracks with percolation of fluid along their structure.

**Figure 4:** A) Thermographic photo of the bridge pillars; B) Original photo of the bridge pillars.
