## Effects Of Human Error On Marine Safety: Case Study

## II. CASE STUDY: OIL TANKER AND CARGO SHIP COLLISION

On July 24, 2017, at 11:09 am, the cargo ship “Unison Star” collided with Kuwaiti oil tanker “Kaifan”, while Kaifan was in the Chittagong - Bangladesh anchorage area. The collision caused hull damage for both ships with no injuries and pollution.

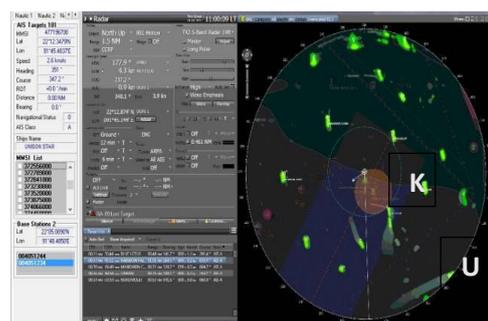
- Unison Star entered the anchorage area with relatively high speed which is against CPA polices to enter in low speed and anchorage at safe distance from other vessels.
- Kiafan’s Captain limited the risk which may affect the tanker based on general conclusions that ships working in this region are familiar and aware of the regulations and have the experience in entering such areas.
- **11:04am:** Kiafan’s bridge sailor and third officer observed that Unison Star began to retreat away from the Blue Lotus mainly due to water current effect (4.1 knots) and began to swing sharply towards the starboard direction, where it highly affected by the current in the horizontal direction. The Unison Star was on a 322o course and was running at 5.5 knots and Kaifan direction was 166.3o and the sea current was 4.1 knots as indicated in Fig. (6).

- Unison Star did not consider /estimate the high effect of water current in this area.

**Figure 6:** Radar Location of Kiafan’s “K” and Unison Star “U” (24 July 2017: 11:05) [12]

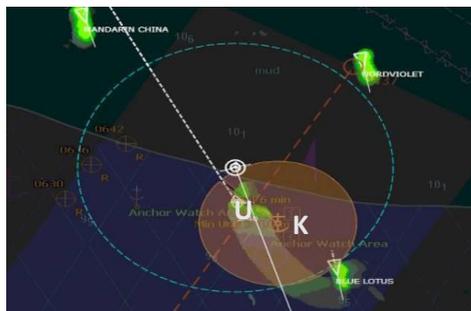
- Unison Star response to Kiafan radio directions. This clarify that they were able to receive the calls but they did not answer. Moreover, they did not response to the requested action by Kiafan to avoid the collision.
- Kiafan Tanker: bad evaluation of the situation led to delay in taking actions toward moving the tanker in full speed to the rear direction. This clarify the effect of experience in dealing with such situations.
- **11:09am:** the Unison Star was approximately 1.0 nautical miles from the front of Kiafan tanker. Kiafan’s captain realized that the collision was imminent, therefore he triggered the alarm and announced the possibility of collision. The collision happened at the left rear of the Unison and up to midway with the front of the Kiafan as indicated in Fig. (7).

- Unison Star: loss of ship control due to lack of experience and violation of port authority polices, where it is clearly indicated that crossing of bow at close range shall never be attempted.

**Figure 7:** Radar Location of Kiafan’s “K” and Unison Star “U” (24 July 2017: 11:10) [12]

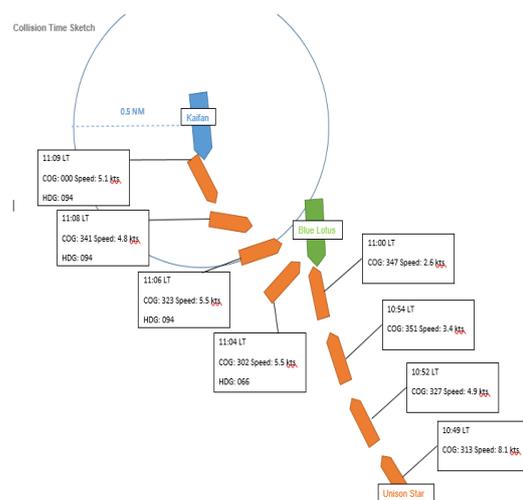
Fig. (8), shows a sketch diagram to the main collision time. The Figure illustrate the first possible collision between Unison Star and Blue Lotus, which not happened, and the collision events between Unison Star and Kiafan.

**Figure 8:** Illustration Sketch for Unison Star Collision Scenarios [12]

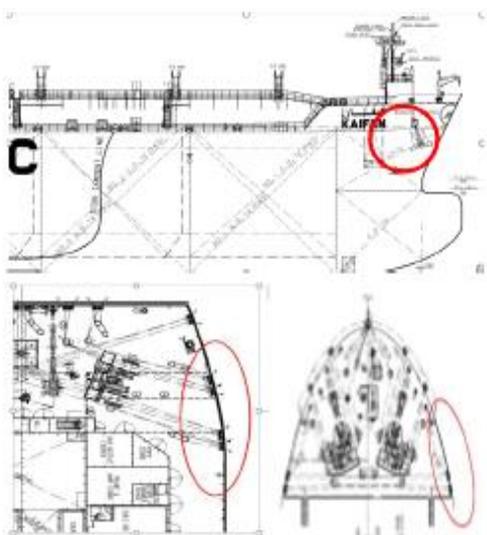
The collision caused hull damage for both ships with no injuries and pollution. Beside the hull damage, Unison Star lost the main propeller and extensive maintenance needed to the main propulsion system. The detailed report of the damages caused by the collision to Kiafan oil tanker indicates the followings [Ref. Report]:

- ◆ Structural Damages include:
  - Shell plates damage and members deformed at forward starboard side
  - Shell plates damage and members deformed at bulbous bow
  - Three tie guard rails deformed and broken, emergency embarkation light post damaged, windless compressor damaged at fore castle deck and forward at starboard side
  - Shell plates damage at wing tank starboard side
  - Shell plates damage at wing tank port side
  - Shell plates damage at wing tank port side
  - Ship side shell plates damage at pot quarter Webs, side longitudinal and transverse frame deformed at steering gear room at port side
  - Aft bulkhead, web frames and scupper pipe deformed at engine room internals of port side shell plate
- ◆ 12 shackles of port anchor chain lost to sea
- ◆ The location of collision damages to Kiafan at forward port and starboard sides are illustrated in Fig. (9).

Figure 9: Locations of Kiafan's Hull Damages due to Collision [13]
