## QUALITY MANAGEMENT OF WATER SUPPLIES UNDER 24x7 SCHEMES, AT SECTOR NO. 21, PCMC, PUNE

Ms. Namrata B Patil\*, Dr. W N Deulkar\*\*

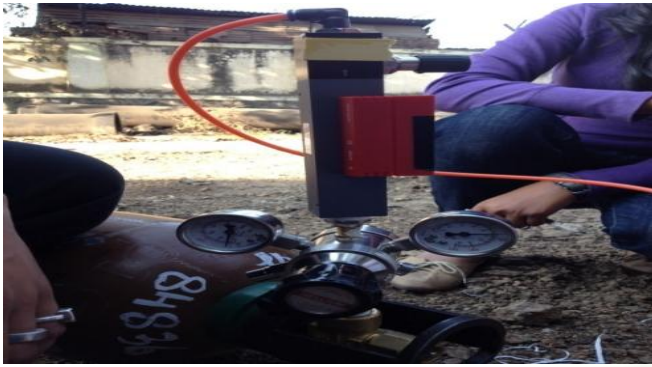
Figure 2.1 Pressure meter with helium gas cylinder

1. Helium Injection
  - Initially, a cylinder of Helium gas is fixed to the outlet of the ESR
  - The injecting pressure of the Helium gas was maintained such that 30% of the Helium gas in the cylinder has to be injected in 30 minutes. For this criterion, the pressure was to be maintained at 9.5 kg/cm<sup>2</sup>. (Fig.2.1)
  - The pressure was checked at an interval of 15 mins.
  - A Pressure-meter to measure the pressure of the water in the pipe was attached to the pipe.

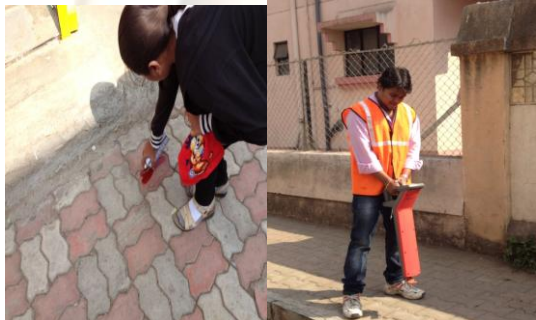
Figure 2.2 Leak detection

- With the help of Pipe & Cable Detector, the underground pipes and cables are detected. Fig.2.2(a)
- The Locator is having the receiver and transmitter; receiver is divided in two parts – Antenna & Receiver. Fig.2.2(b)
- The Receiver receives reflected waves from the cables and indicates the location and the depth of cables. After detecting the cable, a hole is drilled at every 2 m. to 3 m. apart from the point where the cable is detected so as to avoid drilling in the cable. The depth of the hole is 40 cm. Fig.2.2(c)

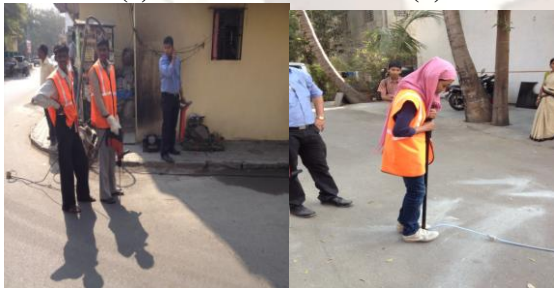
- Above the drilled holes, a vacuum pipe is placed that is connected to the Spectrometer Fig.2.2 (d). There is a filter in between the vacuum pipe and spectrometer which filters the moisture and soil particles coming from the vacuum pipe, if any. Only air is carried away further.

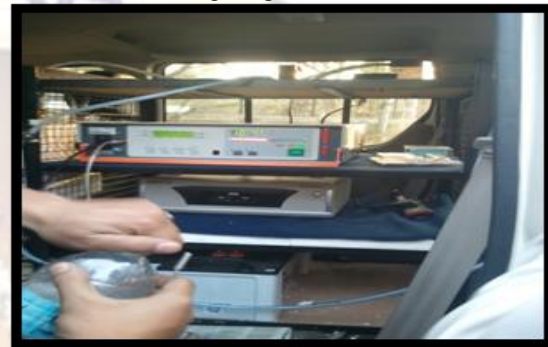
Figure 2.2 Pictures during leak detection

- Next to the filter there are two jars containing silica gel (Blue color). A sniffing probe is connected to one of the jars.
- The silica gel filters the moisture if any after filtering and hence protects the spectrometer.
- The filtered air finally enters in the spectrometer. The spectrometer then shows the amount of the Helium gas. The saturated concentration of helium is  $3.5 \times 10^{-6}$  Kg/cm<sup>2</sup> in the atmosphere but if the spectrometer reading is exceeding  $7 \times 10^{-6}$  kg/cm<sup>2</sup> then there is a possibility of leakage. At such case, few more holes are drilled along the radius of the detected hole, if the reading is increasing or up to  $7 \times 10^{-6}$  Kg/cm<sup>2</sup> then surely there is a leakage. Fig.2.2(e)

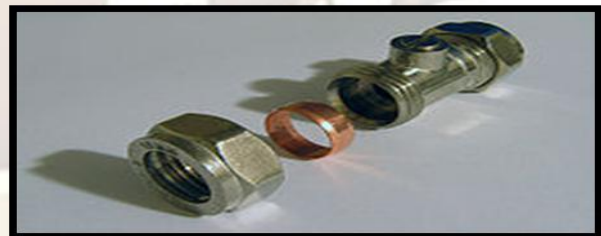
Figure 2.3 ferrule connection

1. Ferrule Connection: ferrule is used when at end of pipe leak is found. Following Fig. 2.3 shows the ferrule connection.

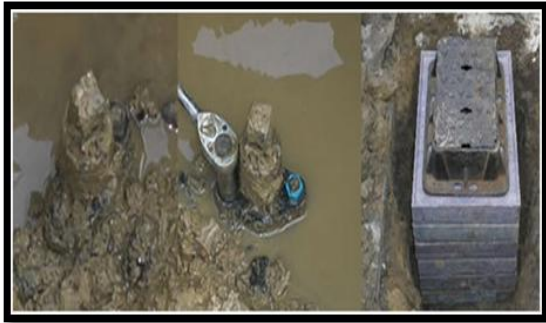
Figure 2.4 sluice valve repair

A Sluice Valve is often used on larger diameter mains (2" or greater) mainly for industrial and commercial feeds. This works covers or maintenance and renewals of any type of Sluice Valve including, chamber frame and cover rebuilds, repacking glands, is spindles, repairs to bolts and flange plates and full replacement of valves with main work. Figure 2.4 shows the sluice valve repair

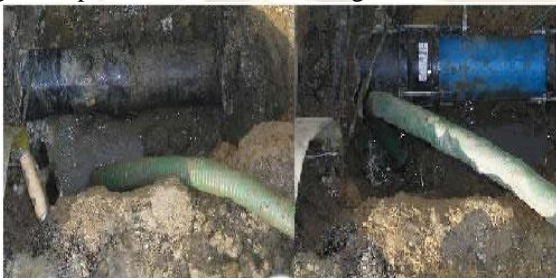
Figure 2.5 mains repaired connection at sector 21

This covers all repairs and maintenance of all water mains and supply pipes greater than 1” in diameter. There are many different types of materials that have been used in the installation of water mains from Asbestos Cement, PVC, Medium Density Polyethylene (MDPE), copper, galvanized iron to the more common ductile and cast-iron. With this there are many fittings to adopt and maintain these different materials for use in repairs to water mains, new connections for supplies to properties and general preservations, refer the Fig. 2.5 below.

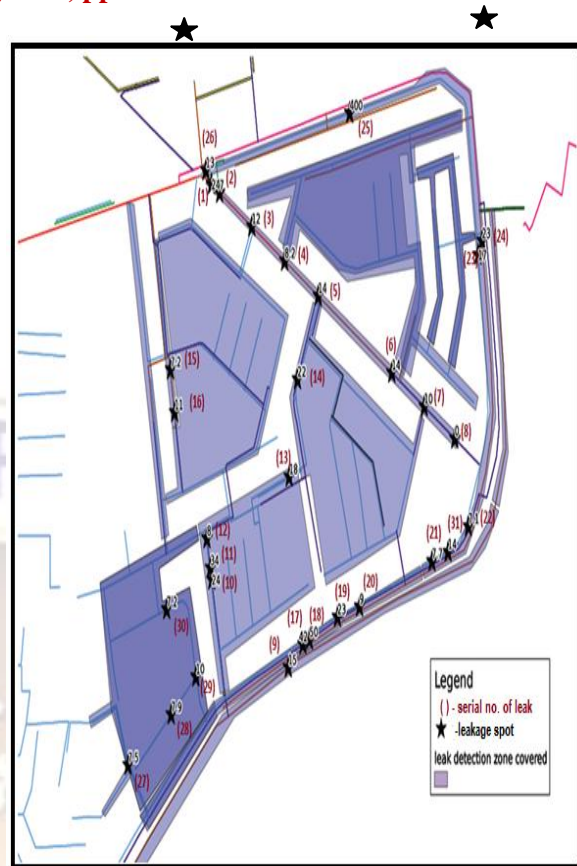
Figure 3.1 Details of pipe with leak spot and Helium concentration

While detecting leakages on pipeline, we studied 31 leak spots out of 31 leaks, 5 do not have any leakage and 26 were having leakages which were repaired. The position of various leak points is shown in the figure 3.1 which are marked by star ( \* ). The number followed by star ( \* ) indicates Helium concentration obtained and the numbers mentioned in the bracket with red colour indicates the serial number of leak.

Having detected all leakages, their repairing was done on the site with immediate action so that the accidents could not be taken place by the excavated trenches and also to avoid the water loss at the leak point. The detail information about leak point and its repairing is mentioned in the table 4.1. Table 4.1 Information about the leakage area and type of leakages:
