Documentation for Restoration of a Heritage Educational Monument: A Case Study

This study aims to prepare such documentation for future restoration of a heritage educational monument using it as a case study. The monument selected in this study is India's third oldest engineering college, "College of Engineering, Pune (Maharashtra)". The College of Engineering Pune is 167 years old educational monument constructed in 1854 under the British regime using naturally available basalt stones.

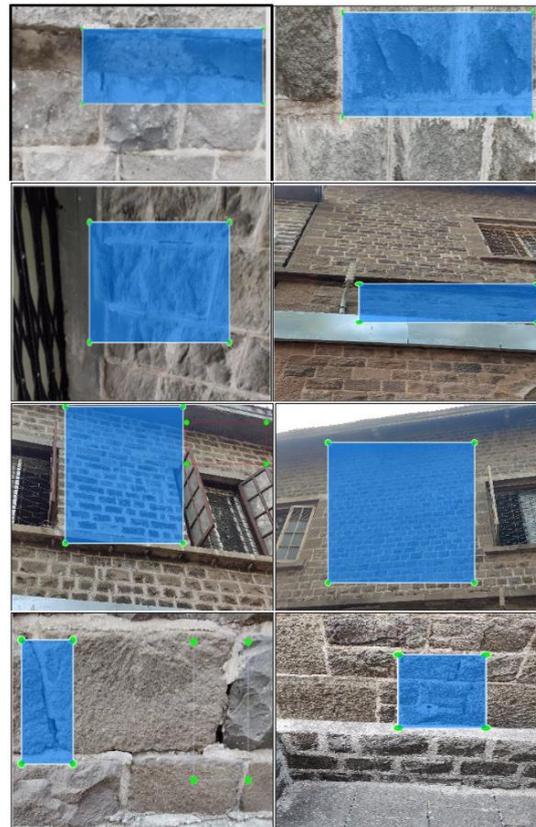
The digital photographs of the Civil Engineering building were examined, and three defects were identified spalling defect, discoloration and jointing/pointing defect. Total 192 photographs of Civil Engineering buildings were run on the LabelImg software, and labelling was done on the photographs having a defect. Out of 192 photos, 11 photos had a spalling defect, 12 photos had discoloration defect, and 10 photos had jointing/pointing defect. Figure 13 represents sample labelled images where the first row represents spalling defect, the second row represents discoloration defect, and the third row represents jointing/pointing defect.

Fig. 13: Labelled Photos of Civil Engineering building (Spalling, Discoloration, Jointing/Pointing defect)

- Spalling defect occurred due to the salt crystallization phenomenon. The structures are situated in an area which sees large traffic volumes every day, the pollutants from the air pollution get adhered to the surface along with dust particles. When rainfall occurs, these pollutants and water penetrate the stone surface; the sulphate and nitrates in basalt stone react with water and undergo salt formation. When evaporation due to sunlight occurs, these salts crystallize and come to the surface of the stone. The crystallized salts eventually wither away, creating partial or complete spalling. If the stone surface is in a protected environment, these salts form a black crust on the stone surface.

- Discoloration defect occurred due to alternate wetting and drying of the stone surface. The basalt stone has pyroxene, olivine, and iron minerals. These three minerals are affected easily by weather conditions as pyroxene is susceptible to temperature changes, olivine is unstable to weathering, and iron reacts with rainwater, resulting in the formation of iron oxide. As the selected buildings are more than

- Jointing/pointing defect occurred due to two reasons. First is vibrations, the past and the current construction activities in the vicinity of the structure caused vibration in the jointing material between the stones. As the selected buildings are more than 100 years old, such vibrations over a long time caused the pointing material at the stone surface to wither away. Second is alternate expansion and contraction of jointing material, lime mortar tends to absorb water and expand quickly, the rainwater causes the lime mortar to expand, and due to evaporation, the lime mortar again contracts, such alternate expansion and contraction of lime mortar between stone over long-time caused the jointing/pointing defect.

- The best way to remove the jointing defect is to do repointing. Repointing in heritage structure is defined as injecting the material between stone connections and filling the cavity. The materials suitable for basalt stone and lime mortar joints are Nanolime, Polyurethane Injection and Epoxy Injection. Nanolime is a mixture of nano-sized calcium hydroxide particles suspended in alcohol such as ethanol. Polyurethane is a resin polymer, and the polyurethane injection method uses a mixture containing polyurethane resin, isocyanate and polyol. The epoxy injection uses epoxy resin suspended in an alcoholic medium. Out of all three, nanolime is considered best due to its compatibility with lime mortar. Nanolime consists of nano-sized calcium hydroxide particles that get highly activated due to alcohol medium, making it suitable to work with ancient lime mortar and a nano-sized particle with deep penetration property.

- To reduce the discoloration defect, using a suitable sealant material as a coating serves as the way. For the basalt stone, the use of titanium dioxide as a sealant is considered as suitable. This solution serves as a coating to the stone surface, which reduces the discoloration and helps retain the structure's aesthetic appearance. It has the property to withstand weathering effects such as heating, cooling and rainfall.

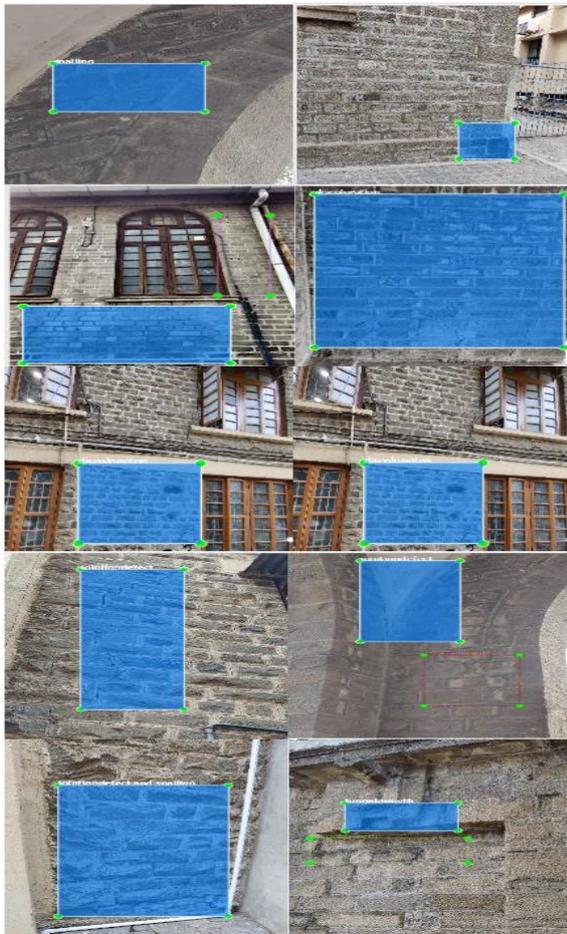
The 180 photos of the Mechanical Engineering building were examined, and five types of defects/damages were identified: spalling defect, discoloration, jointing/pointing defect, fungal growth, and stone damages. The 180 photographs were run on the LabelImg software, and defects/damages were labelled accordingly. Out of 180 photos, 5 photos had a spalling defect, 10 photos had discoloration, 10 photos had jointing/pointing defect, 4 photos had fungal growth, and 2 photos had stone damage. Figure 14 represents sample labelled images where the first row represents spalling defect, the second row represents discoloration defect, the third row represents jointing defect, and the fourth row represents fungal growth. Figure 15 represents stone damages.

Fig. 14: Labelled Photos of Mechanical Engineering Building (Spalling, Discoloration, Jointing/Pointing defect, Fungal growth)

- The most necessary condition for fungal growth to occur is dampness. The presence of dampness over a long period leads to fungal growth on the structure. The areas where this defect was visible were the ones directly exposed to rainfall. The rainfall got absorbed on the stone's surface, which was porous and created dampness, resulting in fungal growth.

- The material to remove fungal growth is glyphosate, ammonia solution, and lime mortar mix. It's a three-step process; in the first step, physical or chemical cleaning is performed. In physical cleaning use of soap water solution, pressure water sprays or moist pulp paper is used for cleaning the surface. In contrast, chemical cleaning, diluted acid or alkali is used for cleaning such as sulphuric acid, acetic acid, sodium hydroxide or potassium hydroxide. In the second step, the mix is prepared, and in the third step, the mix is applied on the surface in thin layers to prevent future fungal growth.
