## Results and Solutions for Unit Corrosion Breakdowns

Done by Eng. Essa M. A. Alruwaieh

**Keywords:** CORROSION BREAKDOWNS , Heat Exchanger Corrosion, corrosion control in vacuum

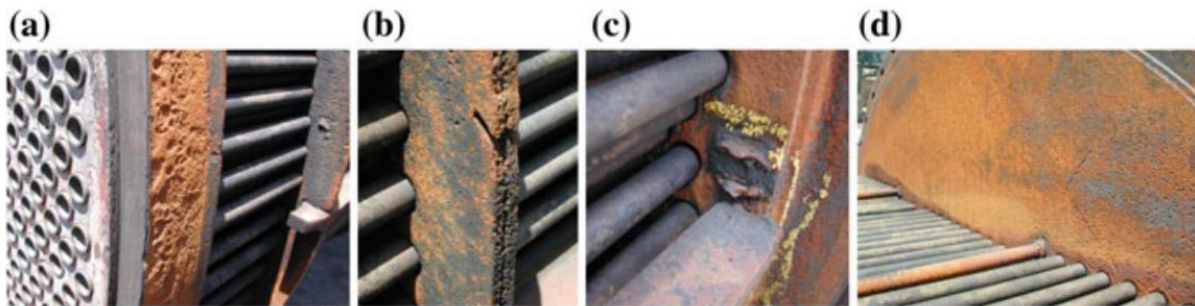
--- Visual inspection and findings: Grooves, cracking, dryness, and sponginess of the surface

were found on carbon steel dividers and tube-sheet from the processing side (Fig.1).

When carbon steel came into touch with copper-nickel tubes, it too corroded. Additionally, the exterior of copper-nickel tubes was found to have pits.

Acid, pitting, as well as galvanic corrosion are the failure phenomena. ---

• Failure's root cause and justification: And per the morphology of failed surfaces of baffles and tube-sheet, light organic and inorganic acids (including H<sub>2</sub>S) impacted carbon steel surface areas in the form of separating (delamination), porosity, sponginess, and cracks. Attacks of this kind were caused by nascent hydrogen atoms that were liberated during the cathodic process and spread through carbon steel (see Fig.1). Once hydrogen sulfide (H<sub>2</sub>S) came into contact with copper-nickel tubes' outer surface, pits were created.

Figure 1(a) bulkheads and corrosive steel sheets (process side). (b) erosion baffle. (c) A weld that is completely rusted and ruined. (d) The tubular plate's etched surface (process side)

- Carbon steel that has been harmed by hydrogen produced as a result of an acid-corrosion reaction cannot be repaired.
- Tube panels and baffles constructed from A516 or killed steel.
- Injecting the acid corrosion inhibitor into the vacuum distilling system's top.
- Carbon-nickel-copper tubes, as corrosion inhibitors based on iron are used to treat coolant water and corrosion-resistant alloys are not necessary.

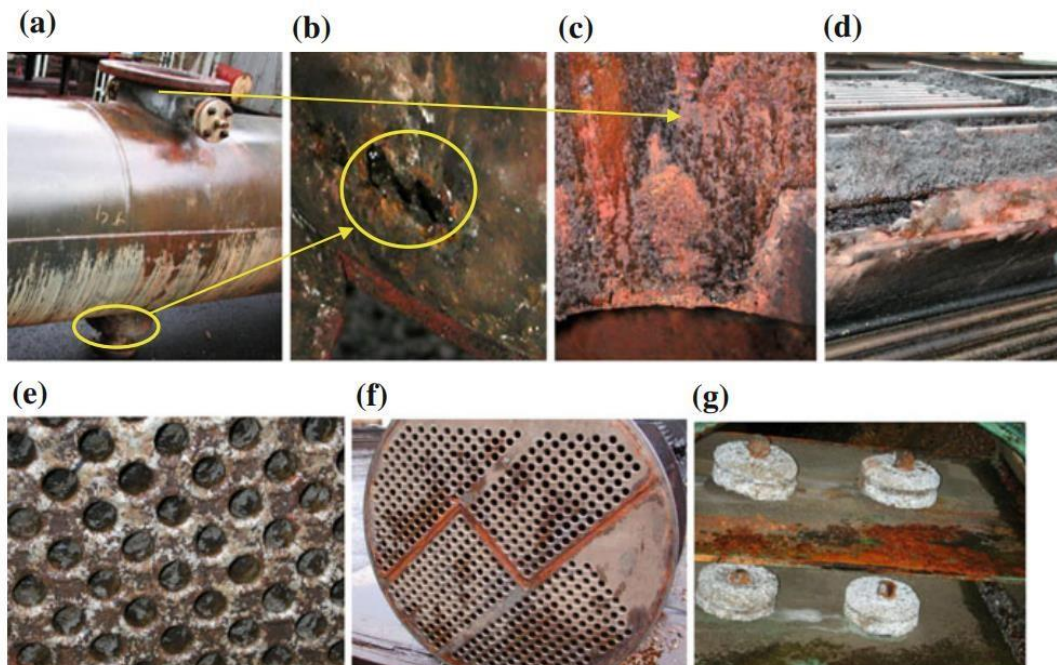
• Optical inspection as well as results: In the initial step of visual inspection, the hole (diameter 10 cm) was observed. vacuum condenser boot, or bottom (Fig. 2). The upper portion of the condenser, which is where water vapor and hydrocarbons enter, was severely corroded. The titanium tubes seemed to be in good shape. Deposits deposited on the outer surface of titanium tubes. The chemical make-up of the aquatic condensation in the condensation vessel was assessed once per week. pH values fluctuated between 3.6 and 4.1 (all through the year prior

to the collapse; alternately, 5.5 and 6.5 are stated) and pH = 8 to 9.8 at times. The amounts of chloride ions ranged from 42 to 56 parts per million (instead recommended 10 ppm maximum). Only the condenser's input saw carbonate scale emerges

from titanium tubing. The sacrificial anodes worked well. On the other end of the condenser, the coolant water outflow was in good shape. The performance of aluminum sacrificial anodes was excellent.

**Failure phenomenon: Acid corrosion. ---**

Figure 2 (a) The first vacuum capacitor as seen from above. (b) The hatch at the bottom (10 cm) (luggage compartment). (c) The condenser's rusted top portion. Sedimentation on the condenser's titanium tubes' exteriors. (e) The scale is on the tube sheet and within the titanium tubes (cooling water side). (f) The adversary (cooling water). (g) cooling water with aluminum anodes used as sacrifices (inlet channel).

• **Failure's root cause and justification:** Induced by an aqueous acid solution that contains chlorides. The first vacuum condenser's internal structure has suffered from significant, widespread corrosion. The dose of amine neutralizer given was inadequate. In every case, overdoses occasionally happened, causing the aqueous condensate to have a pH of 8.0 to 9.8, which caused salt deposits to form.

- a) Ti Gr.2 coating the inside surface of the first vacuum condenser
- b) As an alternative, epoxy-ceramic coating (600 lms thickness) or epoxy vinyl ester coating (3 mm in thickness).
- c) Coupling the injection of a corrosion inhibitor and neutralizer.

d) Continuous pH and corrosion rate measurements should be made.

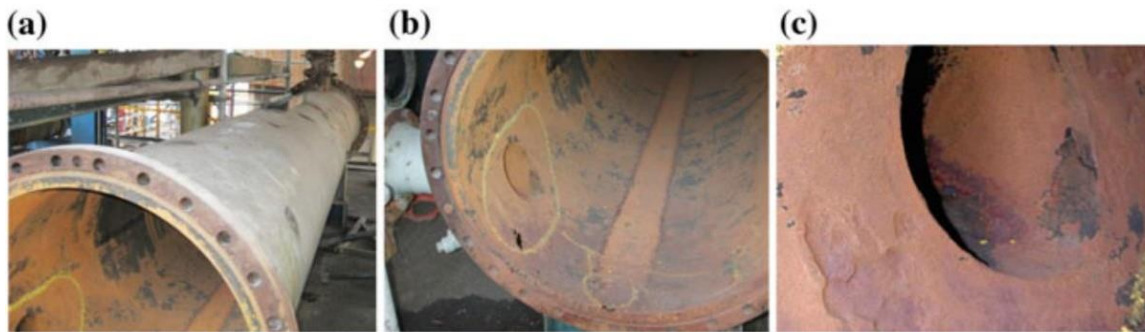
Figure 3(a) shows the second vacuum condenser's shell's damaged inner surface. Localized corrosion from the second vacuum condenser can be seen in (b,c) close to the water condenser.

- Under sediment erosion, there is a failure phenomenon.
- The cause and justification for the failure: The acid deposits were brought on by it.

a) Weld drill to fix it.

P) Take out the fire with a race from the fire.

c) Install ER sensors to monitor wear status.

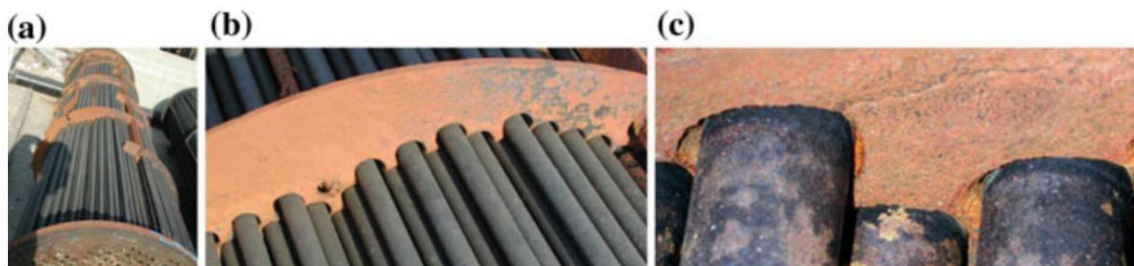
Fig. 4 (a) Overhead condenser (vacuum unit). (b) an Admiralty brass tube and a baffle made of corroded carbon steel. (c) Carbon steel tube-sheet corrosion due to galvanic contact (positions of interaction with Admiralty brass tubes). Brass tubes corroded due to moist H<sub>2</sub>S, resulting in the formation of black copper sulfides.

- **Optical inspection and outcomes:** localized tube sheets and baffle corrosion in locations where they come into contact with Admiralty brass tubes on the process side (Fig. 4). Black copper sulfide scaling coated the outside surface of Admiralty brass tubes.

- **Failure phenomenon:** Low-Temp sulfidic corrosion, galvanic corrosion.

**Source of failure and its clarification**  
 Hydrocarbon gases were discovered to include H<sub>2</sub>S and water vapor, which explains why the system failed. When the water phase condensed, H<sub>2</sub>S that had been dissolved there began to destroy the brass tubes used by the Admiralty. Galvanic corrosion manifested itself where carbon steel baffles and tube sheets came into contact with Admiralty brass tubes.

a. A raw material to substitute chemicals with Ti Gr.2 search machines. This resistance has proven resistant to the medium present in the discharge. There can be a solid stream of air. The baffles shall be prepared of SS 316 As SS 316 and Ti Gr.2 have virtually similar electrode prices and no galvanic corrosion risk, the baffles must be manufactured of SS 316.

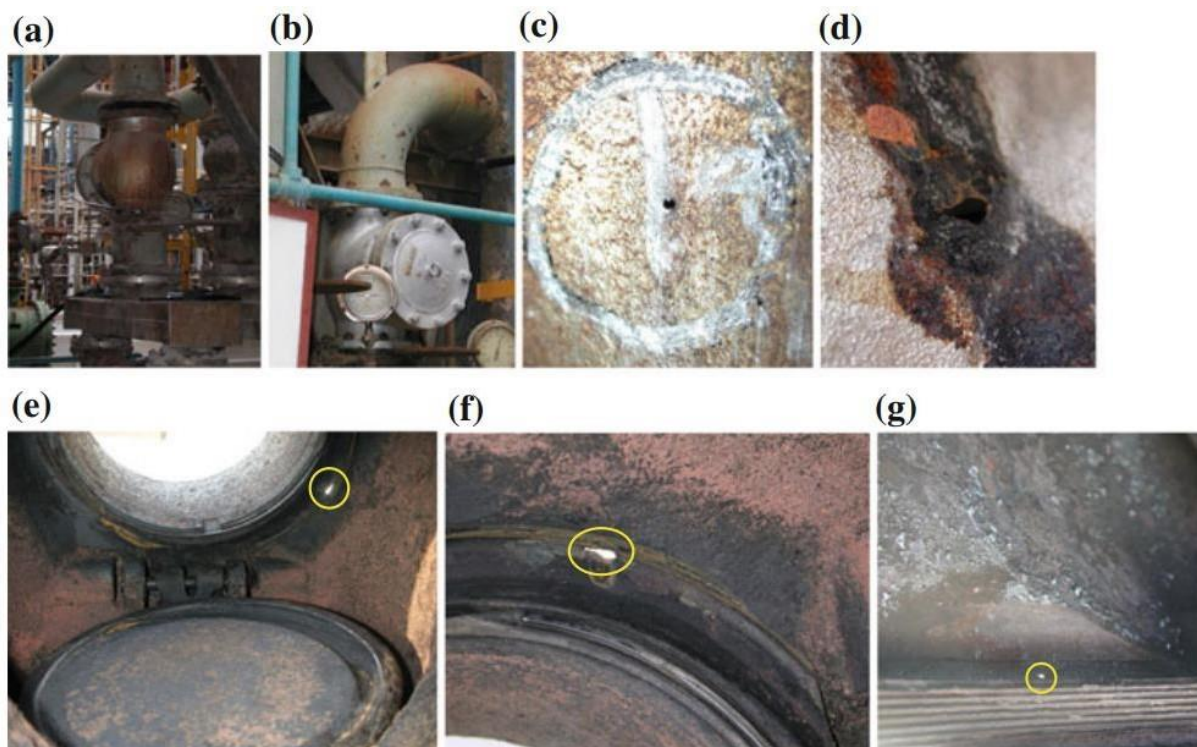
**Building components:** ASTM A216 WCB carbon steel Afore the failure, there was a one-year period of service. Visual inspection and conclusions in the body of two valves, two holes (12 and 2 mm in diameter) were discovered (Fig. 5). Inside two valves, black iron sulfide corrosion yields were discovered on the exterior of the moving disc, bolt, pin, and other fittings. After condensation, the pH of the water ranged from 3.8 to 7.8, although it was usually around 4.

Figure 5 (a,b) Positions of faulty valves in the vacuum unit (a,b). the valve body has perforations caused by corrosion (outside view). e- an interior view of worn holes and rusted internal components.

□ **Failure phenomenon:** Low-temperature sulfidic corrosion and wear.

□ **Reason of failure and its justification:** Sour water with a pH of \* 4 was generated by dissolved H<sub>2</sub>S in water condensate. H<sub>2</sub>S attacked the internal surface of carbon steel valves besides other components of valves. When the dimensions of the moving disc shrank due to corrosion, contact between the disc and the valve body was inadequate, resulting in no tautness. The unrestricted motion of the disc led the internal surface of the valve's figure to wear away, and the bulk's wall thickness eroded from 12.5 mm to zero (until the formation of holes).

a) Injecting the neutralizer and corrosion inhibitor at the proper amounts into the refinement vacuum system's overhead.

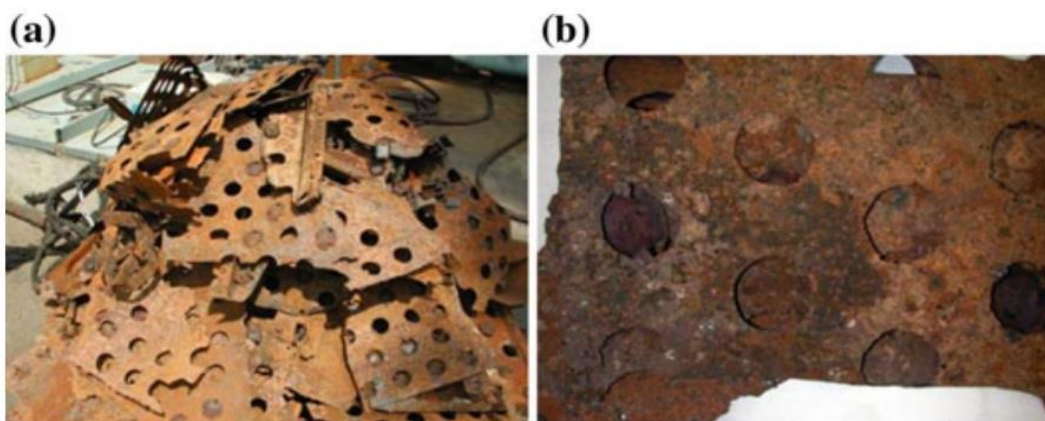
- Construction materials: carbon steel.
- Failure phenomenon: general wear.
- The cause of failing and its clarification:

In the presence of washing water, air was damaged in the oxidation of hydrogen sulfide and the formation of sulfuric/sulfuric acids. At a temperature of 60-80 degrees, two acids corrode the carbon steel trays in the tower. Of great importance are the temperatures.

Figure 6 (a) shows rusted trays in a general perspective; Figure 6 (b) shows the image enlarged

- a) To swap out carbon steel trays for austenitic stainless-steel trays made of 20Mo-6 or 20Cb-3.
- b) Because sulfurous/sulfuric acids may form in this case, wash water shouldn't be utilized.

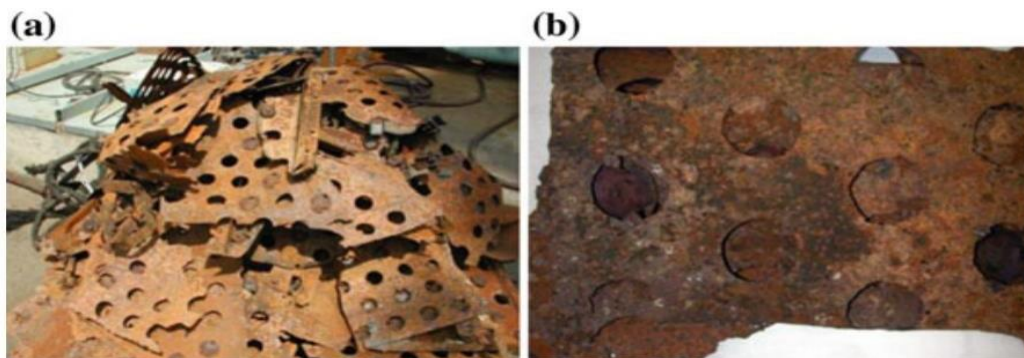
**Optical inspection and outcomes:** The hole in the header's center was made twice, two nozzles apart. When the carbon steel patch (12 mm thick) was initially fitted, the hole (4 cm in diameter) was reformed precisely in the patch's center after four months (Fig.7). 36 millimeters of corrosion occur per year at this pace. In the two months prior to the event, the pH of quench water varied between 2.2 and 3.0, according to PI data. Black deposits and a pipe blockage were found within the air cooler. The deposits contained corrosion byproducts such as iron sulfides and sulfates.

- **Failure phenomenon:** • Erosion and acid

corrosion (by turbulent flow).

• The presence of iron sulfides in deposits shows that carbon steel was badly corroded by H<sub>2</sub>S dissolved in water, **which is the cause of failure and its explanation**. Such a high rate of corrosion (36 mm/year) could only be brought on by the presence of H<sub>2</sub>S in the water. The production of two acids, H<sub>2</sub>SO<sub>3</sub> and H<sub>2</sub>SO<sub>4</sub>, suggests that the reactor's gas SO<sub>2</sub> was not transformed to H<sub>2</sub>S, as evidenced by the formation of these two acids. At 80 °C, these two acids extensively damaged carbon steel. The corrosion rate of 36 mm/year only materialized in the presence of these acids at high temperatures (80 °C) or when erosion (turbulent flow of acidic solution) took place. Blocked pipes and nozzles allowed corrosion products from the stream to enter the air cooler. Pipes at the ends of the header were blocked in front of the quench water intake (two nozzles). In the center of the header, a turbulent flow of an acidic aqueous solution developed, speeding up corrosion. The laboratory measurements of 36-258 mm/year of carbon steel corrosion rates by H<sub>2</sub>SO<sub>4</sub> are evidence of this corrosive process (Table 5.1).

Fig. 7(a) the air cooler in broad terms. (b) The gap and repair

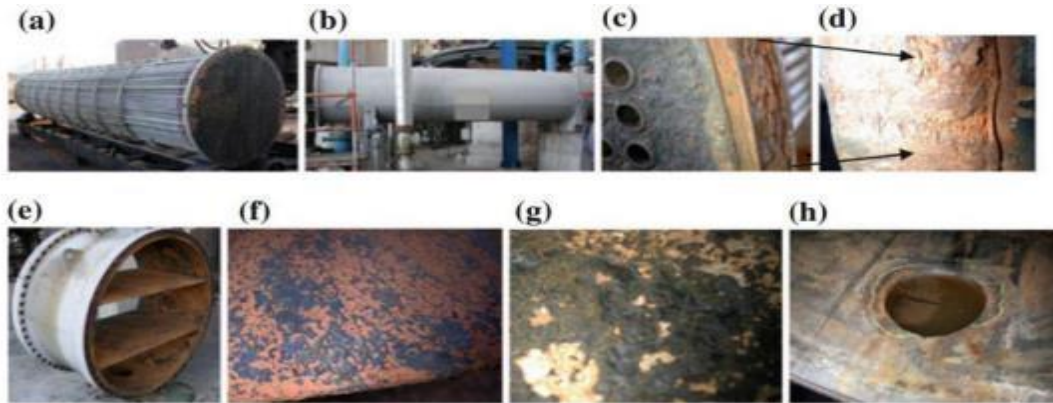
- Examination and results: Corrosion was found at the succeeding positions of the heat exchanger (Fig. 8):

(a) The wear of the tube plate is localized at the cladding. The shape of the damaged area is characteristic of acid assault (see Fig. 8c,d).

(a) Corrosion due to galvanic action (portion of the tube sheet in interaction with SS 316L clad).

(b) Erosion in common (the internal surface of the canal).

The pH of the acid should be between 0.5 and 3 over a period of several months, and it should have a pH of around 8. This is the reason and explanation for the failure. I want it to just contain weak acids like H<sub>2</sub>S, which cannot produce such pH levels. The pH can drop significantly (to 0.5-3) as a result of the creation of the acids H<sub>2</sub>SO<sub>3</sub> and H<sub>2</sub>SO<sub>4</sub> when the ratio of H<sub>2</sub>S/SO<sub>2</sub> at the HDS unit's outlet is off. This happens when the acidic gas SO<sub>2</sub> passes through the TGT reactor (tail gas treatment) and dissolves in the sour water. This often happens when acid gases enter the system and it is switched off. The reaction to sudden fluctuations in H<sub>2</sub>S concentrations can be managed under steady settings. The carbon steel was corroded by the sour, acidic water, which also interacted with the channel's inner surface. Acidic acid tapped into tube plates in the vicinity of carbonaceous material and stainless-steel type 316L and produced galvanic.

Figure 8 (a) The heat exchanger bundle as a whole (HDS unit). the cortex (b). (c) Corroded tube sheets in close proximity to the stainless steel 316L cap. (D) Enlarge the picture. (e-g) the degraded canal's interior surface (sour water). (h) The shell inlet's rusted inner surface (cooling water)

- Replace soured water right away if the pH in the acidic region drops below 7 (pH).
- Keeping processing parameters consistent: making sure the H<sub>2</sub>S/SO<sub>2</sub> ratio at the HDS unit outlet is accurate.
- The temperature of the sour water is lowered by 5 degrees Celsius by this heat exchanger, which functions after the air cooler. Therefore, it's preferable to put it in bypass and only utilize it when the air cooler's performance or the load on it change.
- Rather than employing carbon steel for the tube sheet's cladding, the tube sheet should be made entirely of stainless steel 316L.
- To guard the channel against corrosion brought on by sour water, utilize sacrificial aluminum/zinc anodes and cover the interior surface with an epoxy coating resistant to acidic solutions.

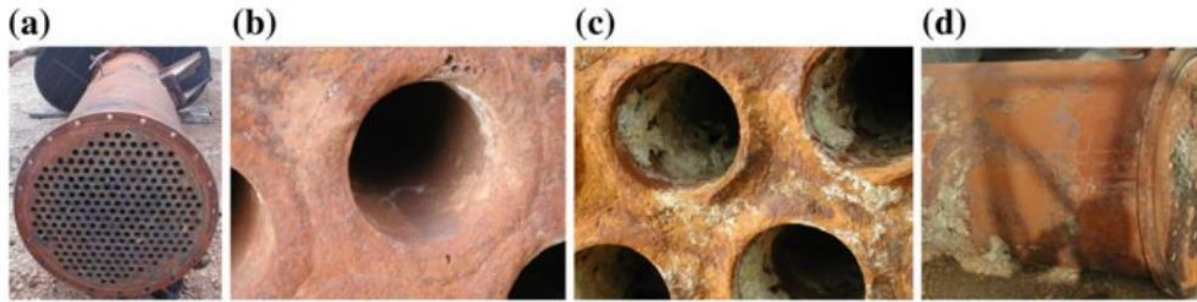
**Optical inspection and outcomes:** Visual inspection reveals extensive corrosion on the tubes' acid gases side in three heat transfer oil heaters (Fig.8). There were pitting degradation symptoms in the welds. The wall thicknesses of the tubes and tube sheets decreased significantly. Large amounts of yellow-black deposits including iron, sulfur, and oxygen were found inside the tubes. After these deposits are dissolved in distilled water, the pH is 3.2. High levels of sulfates were discovered in this solution. Under thermal insulation, it was also found that heat transfer oil heaters outside surfaces were corroding (Fig. 9).it was also found that heat transfer oil heaters outside surfaces were corroding (Fig. 9).

Acid dew point corrosion (inner surface of tubes and tube sheets) **is the failure phenomenon;** corrosion underneath a thermal barrier (outer surface of heat transfer oil heater).

**Failure's root cause and justification:** Water vapor existence caused sulfur oxides (SO<sub>2</sub>, SO<sub>3</sub>) to condense at 150–180 °C hence producing the acids H<sub>2</sub>SO<sub>3</sub> and H<sub>2</sub>SO<sub>4</sub>. These two acids significantly damaged the internal surfaces and tube sheets of carbon steel tubes.

Figure 9(a) an overall view of a failed heat transfer oil heater. (b) The tube sheet's general and pitting corrosion. (c) The tube-sheet and tubes' severe corrosion (deposits are accumulated inside the tubes; the ends of the tubes are out from corroded tube-sheet). (d) Corrosion of the heat transfer oil heater's exterior surface underneath thermal insulation

- HASTELLOY C 276 or FERRALIUM 255 duplex steel tubes should be used in place of carbon steel tubes.
- Coating the outside of heat transfer oil heaters to prevent corrosion under thermal insulation.

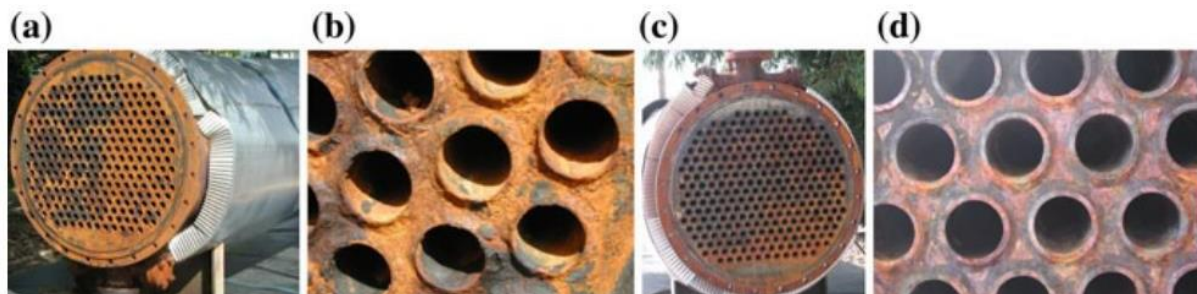
**Optical analysis and conclusions:** At the gas input side, there was significant corrosion of the tube-sheet surface, particularly the welds and tubes end (Fig.10). In the place where the gases depart, the heat exchanger's surface very slightly rusted. Due to repeated interruptions, temperature frequently dropped to below 100 °C, according to PI data (Fig.11). During such outages, nitrogen would need to be cycled, but this circulation wasn't always achieved.

**Failure phenomenon:** Acid dew point corrosion.

**Failure's root cause and justification:** According to the results, acid dew point corrosion was found.

The reaction between SO<sub>2</sub> and H<sub>2</sub>O produces the liquid inorganic acid H<sub>2</sub>SO<sub>3</sub> when the temperature drops below 130 degrees Celsius (the acid dew point for H<sub>2</sub>SO<sub>3</sub>). The concentrations of SO<sub>2</sub> and H<sub>2</sub>O in the vapor phase really control the dew point temperature when an aqueous acidic solution is produced. The gas SO<sub>2</sub> is capable of being oxidized to produce SO<sub>3</sub>, and this often occurs in the presence of a catalyst, which decreases the activation energy of the oxidation. If SO<sub>3</sub> is produced even at T = 130–180 °C, it can combine with H<sub>2</sub>O to form the potent acid H<sub>2</sub>SO<sub>4</sub>. Once the heat exchanger is turned off, two liquid inorganic acids, H<sub>2</sub>SO<sub>3</sub> and H<sub>2</sub>SO<sub>4</sub>, are produced when the gas temperature falls substantially underneath the dew point (130–180 °C). These acids destroyed the tube-sheet and tubes made of carbon steel. For acid dew point corrosion to take place, a few hours were sufficient.

Fig. 10 Heat exchanger failure. (A, B) Gases entering (severely corroded area). (C, D) The gas discharge (slightly corroded area).

• **Proposals and resolution:** In order to stop the development of liquid H<sub>2</sub>SO<sub>3</sub> and H<sub>2</sub>SO<sub>4</sub> acids, a high temperature (above the dew point, T > 180 °C) must be maintained.

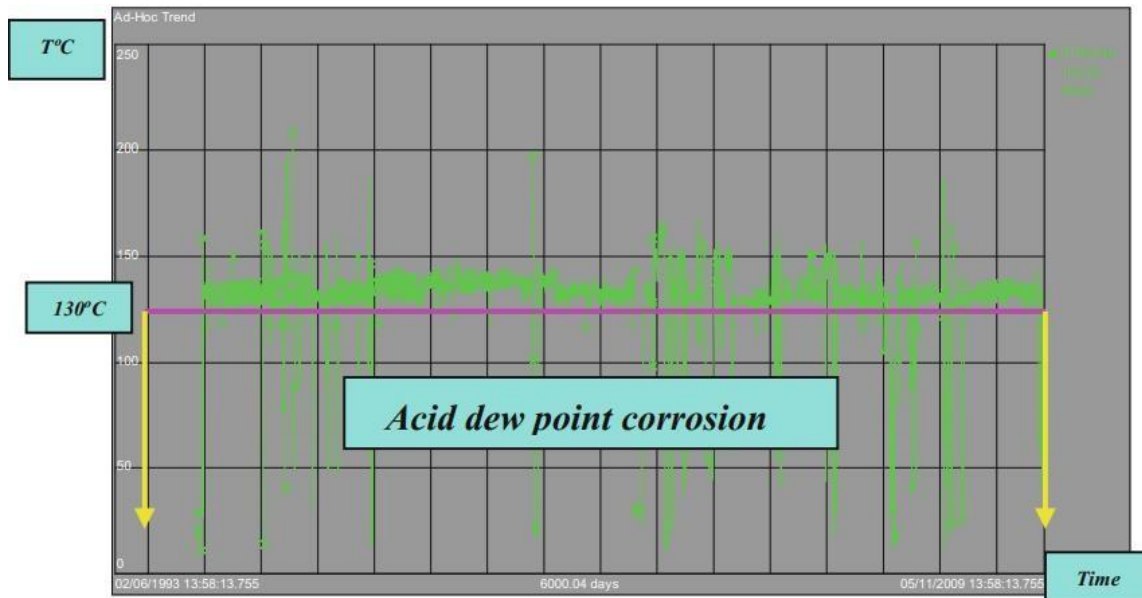
Fig.11 shows time-dependent temperature changes of the entering gases to the heat exchanger (green) (PI data).

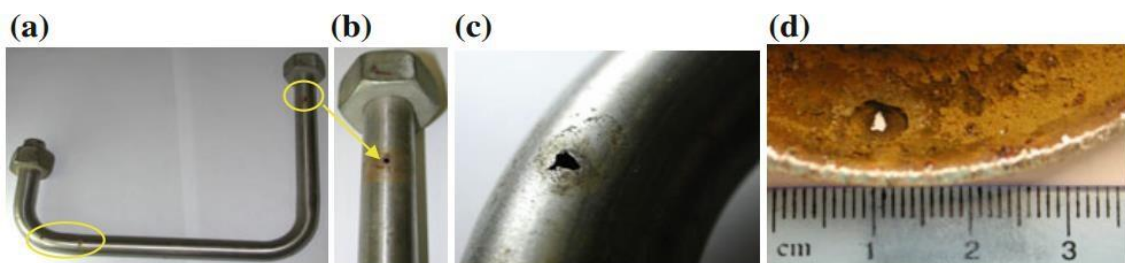
**Visual inspection and outcomes:** reveal that the inner surface of the tube developed holes, and corrosion products were discovered (Fig.12).

• **D-XRF analysis** revealed that the corrosion products that had collected within the tube (in terms of weight percent) were Fe (68.6%), Cr (11.4%), Ni (8.7%), S (7.6%), and Cl (3). a review using chemical analysis of the gaseous mixture. The combination of gases conveyed inside the tube was found to contain H<sub>2</sub>, hydrocarbon gases, chlorides, and water vapor.

Pitting corrosion is **the failure phenomena.**

**Failure's root cause and justification:** Chlorides and water vapor in a gaseous hydrogen-hydrocarbon mixture led to pitting corrosion of the inner surface of stainless-steel tubes. Hydrogen chloride was produced as a result of the hydrolysis of organochlorine compounds.

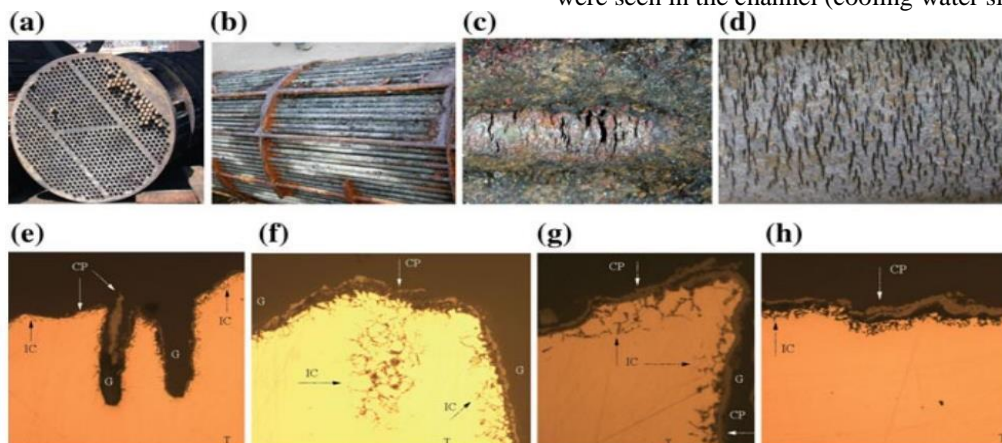
**Visual inspection and conclusions:** Scale and silt were found outside the tubes.(Fig.13b, c). The baffles have extensive corrosion. It was found that the outer surface of the tubes close to the impingement plate had holes, fissures, and grooves. Copper sulfide, which is dark, made up the scale. The deposits contained copper and iron sulfides. Corrosive assault on grain boundaries was discovered during **metallographic analysis**. (See Fig.13e–h).

Corrosion, including broad and intergranular, is a **failure phenomenon**.

**The reason for the failure and its explanation:** Hydrogen sulfide and water vapor present in hydrocarbon fumes significantly corroded the outside of the Admiralty brass tubes. Copper alloys cannot withstand hydrogen sulfide. Localized corrosion at grain boundaries caused grooves to develop. Carbon steel baffles were harmed by hydrogen sulfide and water vapor before they condensed to liquid at 100 °C.

Fig. 13 The bundle of 60 obstructed tubes in (a). (b) Corroded carbon steel baffles and deposits on Admiralty brass tubes. (C, D) Surface flaws including holes, cracks, and grooves on the tube. (e–g) Different magnifications of a metallographic cross-section of grooves (e: x100, f: x200, g: x500): IC—Intergranular corrosion (corrosive assault on grain boundaries), CP—corrosion products, G—grooves, T—tube. (x100) Metallographic cross-section close to the grooves

The material in tubes and baffles will be replaced with Ti Gr.2, according to the **solutions and suggestions**. Ti Gr.2 tube sheets must also be used in place of those in contact on both sides with the cooling water and process stream (LPG).
