“Road Safety Audit: Challenges And Remedies”

To study the various roads traffic characteristics and road traffic crash data at identified road stretch. (NH-

12 Durgapura Bus Stand (9/800) to India Gate (20/300) Sitapura Tonk Road, Jaipur)

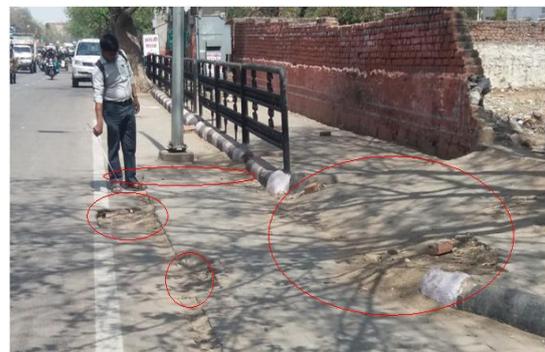
(a) The kerb height of footpath should be at least 100-150mm as per IRC guidelines.

Figure: 2 Discontinue kerb at footpath

Figure 2 showed that the footpath was not properly present at the site further the kerb was also not present continuously.

1. The identified location surrounded by institutional & Industrial area, the footpath should be provided with at least 2.5m wide as per IRC guidelines.

15. All unauthorized median opening should be closed immediately
16. Footpath and pedestrian accessibility condition like pavement type, height of footpath, availability of crossing etc are not in the proper condition. They need to be repair immediately.

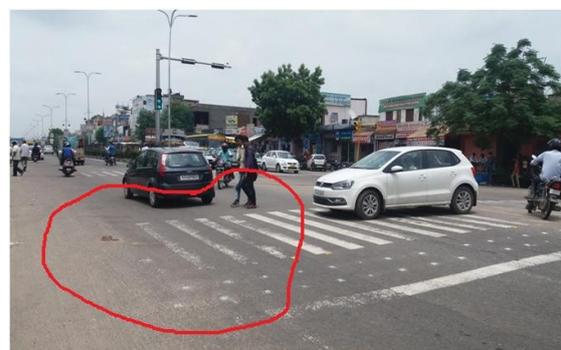
(b) Figure 3 showed that although zebra marking for Pedestrian crossing was present at the site but due to poor maintenance it was faded and was not clearly visible

Figure: 3 Faded Zebra Crossing at Kubhamarg

No proper sign board for Pedestrian crossing was present near the zebra crossing. Further, individual traffic signal time was also absent in traffic signals. This directly develops the confusing behavior among

2. The zebra crossing can be 3m-5m wide for safe pedestrian crossing.
3. The sign post related with speed, gap in median, narrow bridge, fly over, etc should be placed at every point.

12. Should be developed by Jaipur Nagar Nigam.
13. Road side safety barriers should be installed wherever required
14. The pedestrian pathway should be clearly marked to avoid conflict points

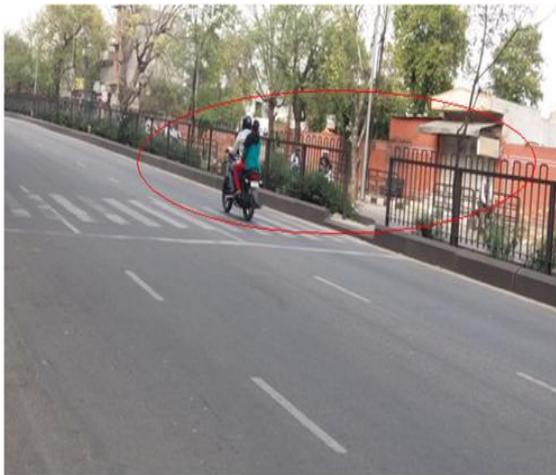
Pedestrians and created conflicts points specially at Intersections. (c) Figure 4.3 showed that the although guard rails were present on median But, the wide, or irregular openings in guard rail with no proper road sign, created a lot of problems. Due to wide openings in guard rail, the two wheeler and bicyclist could cross the road in both directions. Further, wider openings leads to free movement of cattle in both direction.

Figure: 4 Irregular opening of Guard Rail at Kalyan Nagar

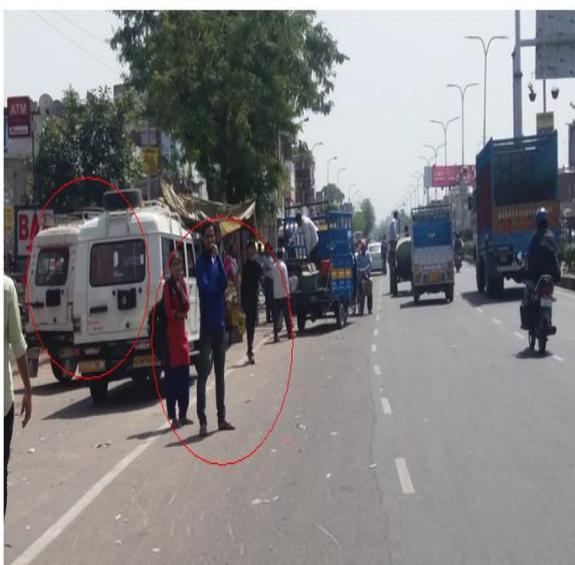
(d) Figure 5 to Figure 6 showed that the Bus - Stop locations were also not present orderly. As per IRC guidelines, the Bus Stops should be 50m apart from each other. It was observed that only Three Bus-Stops were present on the selected road length of 10.500Km. Due to lack of availability of Bus-Stops, Roadways Buses as well as private Buses stopped randomly. Further, people also waited for public transport system on road side and created lot of congestion problems on road side.

Figure: 5 Absence of Bus Stop at Sanganer Booking

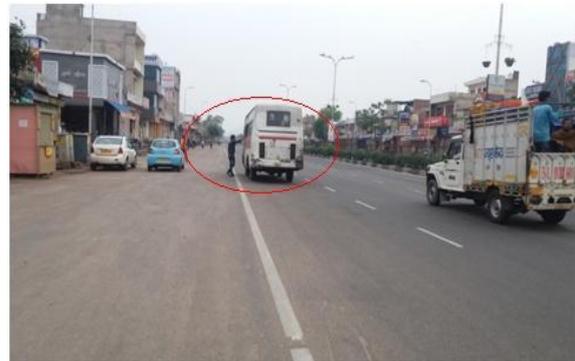
Figure: 6 Absence of Bus Stop at Sector-3 Pratap Nagar

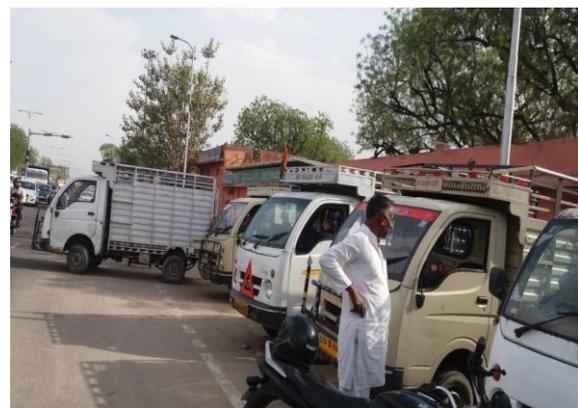
(f) No independent parking space was provided on road side therefore, the vehicles parked randomly on road side and covered a very wide area of the road way.

Figure: 7 Randomly Vehicle Parked at Goshala Bus-Stop

10. Incorporation of safety features in the design and construction of new road schemes.
11. 11 Parking area are n't present at many location. Therefore to avoid enchochment networks. Vendors etc. the non vending should be marked at road side. The separate "Vending Zones"

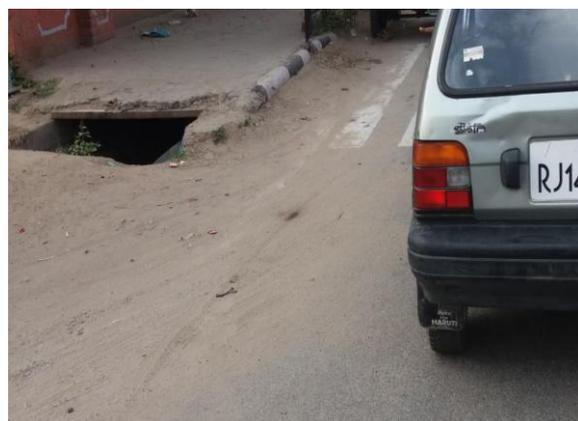
(g) Figure 8 showed that the drainage system was also insufficient and inadequate. It was not covered, properly at many places which directly turned in to a major accidental creating situation among pedestrians.

Figure: 8 The Drainage System are Inadequate at Taruchhaya Nagar
