## Sample Surveying Studies and Sustainability on Education Buildings from the Ottoman Empire to the Republic Of Turkey

Dr. Sibel Onat Hattap "Sample Surveying Studies and Sustainability on Education Buildings from the Ottoman Empire to the Republic Of Turkey "International Journal of Engineering Research and Applications (IJERA) , vol. 8, no. 4, 2018, pp. 85-89

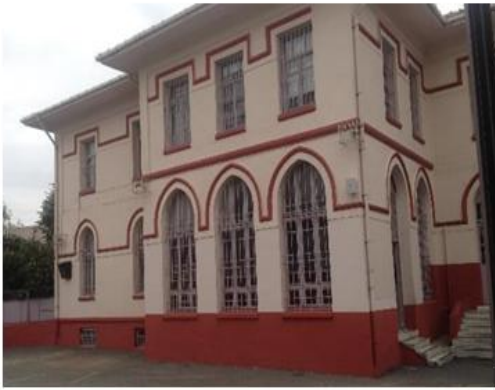
Figure 1. Şemsipaşa Primary School

The Masonry School Located At Istanbul Province, Üsküdar District, Aziz Mahmut Hüdayi Sub-District, Ressam Ali Rıza Sokak No: 4, 376 Block, Parcel No 10 Is Composed Of A Basement, Ground Floor, And An Administrative Floor (1st Storey). The School Still Preserves Its Originality.

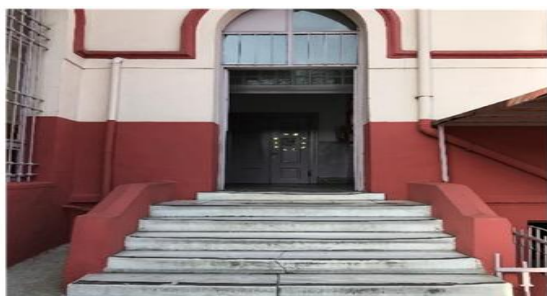
Figure 5. Deteriorations At The Şemsipaşa Primary School

Biological And Microbiological Deteriorations (Mouldings) Occurred On Walls At The South Facade Of The Building. Plaster Heat Change That Has Risen Once The Paint Layer That Protects The Facade Lost Its Function Has Become Open To Atmospheric Conditions Such As Rain, Wind Etc. And So It Has Been Abraded And Surface Loss And Cracks Occurred In Time. Wooden Windows Have Worn Of By The Impact Of Degradation Mechanisms. The Mechanical Deteriorations (Wears And Piece Breakages) Which Occurred On

The Stairs At The Section Of The Building Opening To The Garden Have Been Determined.

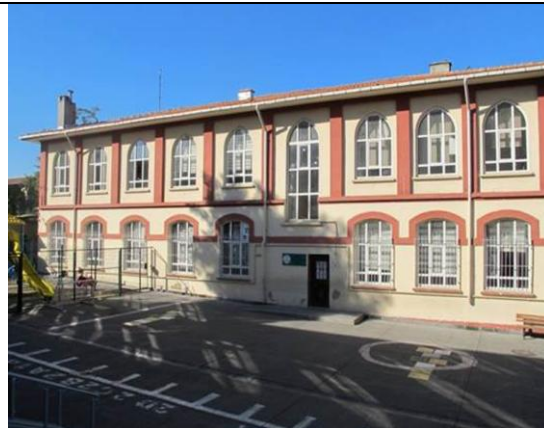
Figure 6. Fatih Counseling And Research Center (Former Vezneciler School For Impaired Hearing)

The Building Is Partially In Good Conditions By Reason That It Is Still Used As A School. However, Paint And Plaster Shedding Occurred In Time On Wall Surfaces Below Windows And Door Sides On The North Facade Wall Because Of Dilapidation. Rain Water Caused Swellings, Deteriorations And Shedding On Paint And Plaster Probably Due To Water Guttering Or Maybe Due To Broken Tiles Are Seen Below Eaves On The Front Facade Of The Building.

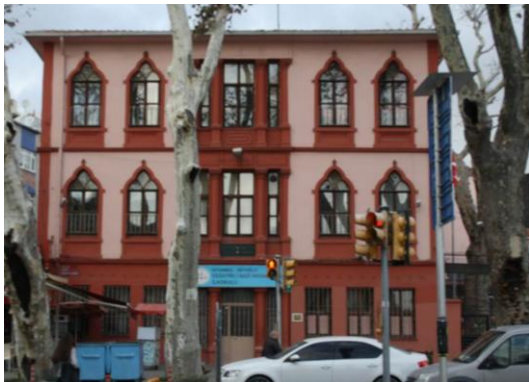
Figure 9. Cezayirli Gazi Hasan Paşa Primary School

The Most Original Facade Of The Building Is The South Facade. An Epitaph, 12 Columns, 8 Arched Windows, 6 Flat Wooden Windows Still Preserve Their Originality On This Facade. However, The Door Of The Building Opening Towards The Street And The Windows Next To This Door Were Not Be Able To Continue Their Existence And Been Replaced By New Metal Door-Windows. Once The Paint Layer That Protects The Facade Loses Its Function, Plaster Heat Change That

Has Risen Once The Paint Layer That Protects The Facade Lost Its Function Has Become Open To Atmospheric Conditions Such As Rain, Wind Etc. And So It Has Been Abraded And Surface Loss And Cracks Occurred In Time.

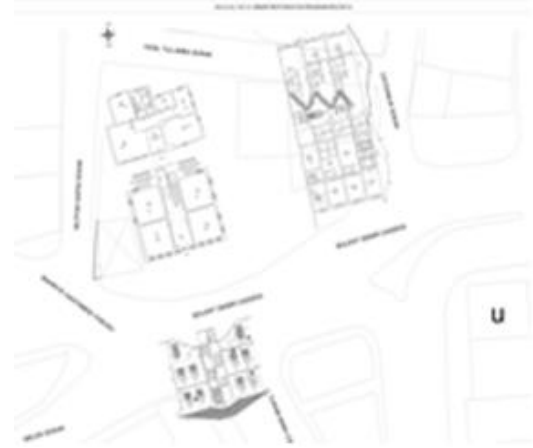
Figure 10. Cezayirli Gazi Hasan Paşa Primary School Situation Plan

Cezayirli Gazi Hasan Paşa Primary School Is Composed Of Two Buildings. Among The Buildings The One Entrance Of Which Is Facing To The Street Is The Main Building And The Other Building Has Been Constructed As Auxiliary To This Main Building. The Main Building Is 3-Storey And The Auxiliary One Is 4-Storey, But The Buildings Have Almost The Same Height Because The Ceiling Height Of The Main Building Is Considerably Higher Than The Other. The Auxiliary Building Has No Stairs System In Itself, All Storey Transitions Are Provided My Means Of The Main Building. For That Reason, It Is Not Possible To Enter In The Kindergartens From The Main Building. It Is Believed That Such A Convenience Was Applied In Order To Sterilize Kindergarten Students From Other Students.

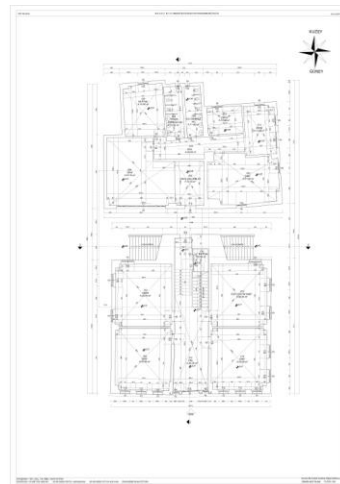
Figure 11. Cezayirli Gazi Hasan Paşa Primary School Plan Survey Work

The Auxiliary Building (Addition) Was Constructed By Reinforced Concrete And The Main Building Was Constructed By Stone Material. When The Wall Thicknesses On The Main Building Are Examined, It Is Seen That Some Internal Wall Thicknesses Drops To 12 Cm, For That Reason It Is Understood That Some Additional Walls Have Been Constructed In Order To Ensure Functional Convenience In Some Sections Of The Building Because The Building Had Not Been Constructed As A School.
