Inspection, evaluation of degradations and maintenance of public primary and secondary school buildings in the city of Yaoundé, Cameroon

The maintenance of administrative or public buildings in general and in particular those of public schools is a serious problem in Cameroon. Very few administrative or public buildings undergo maintenance works in Cameroon after their service. The purpose of this study was to assess the degradations and maintenance of public primary and secondary school buildings in the city of Yaoundé, Cameroon. The methods employed in the collection of data included the administration of questionnaires as shown in appendix to the various principals of public primary and secondary schools in the seven districts of Yaoundé namely, Yaoundé 1, Yaoundé 2, Yaoundé 3, Yaoundé 4, Yaoundé 5, Yaoundé 6 and Yaoundé 7, site inspections and case studies for the sites. The data collected were transformed into frequency counts and percentages for purposes of analyses and interpretation. The findings show that the poor condition of these school buildings is partly due to several causes, namely Non-compliance with the school's internal regulations by the students, thus leading

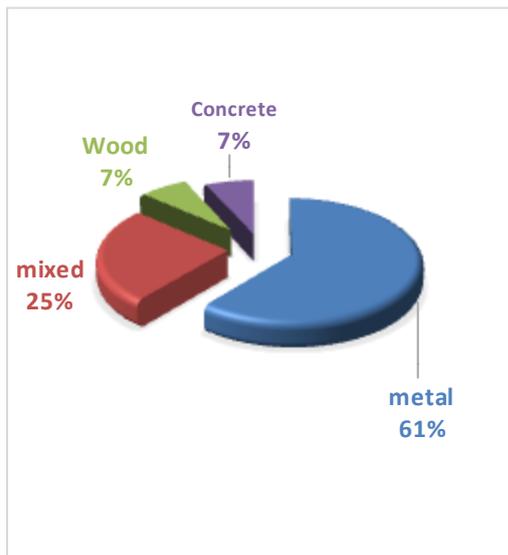
Figure 1. Types of windows

Figure 1 and Figure 2 respectively show the types of windows and doors that can be found on the buildings of secondary and primary school establishments in the city of Yaoundé visited. We observe that most of the windows and doors are made of metal with a percentage of 61% respectively, this is the case for some classrooms, 7% of the windows and 11% of the doors are made of wood this is the case of some offices, 25% of windows and 28% of doors are made of mixed materials and 7% of windows are made of concrete.

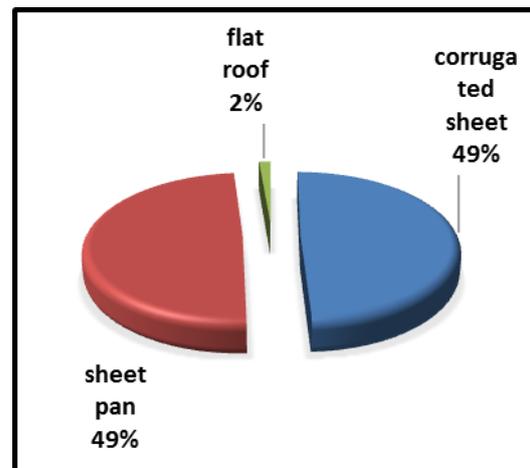
Figure 3. Types of roofing

Figure 3 shows the types of roofing found on the buildings of secondary and primary school establishments in the city of Yaoundé visited. We observe that 49% of the roofs are respectively in sheet pan and corrugated sheet and 2% of the buildings are in flat roof.

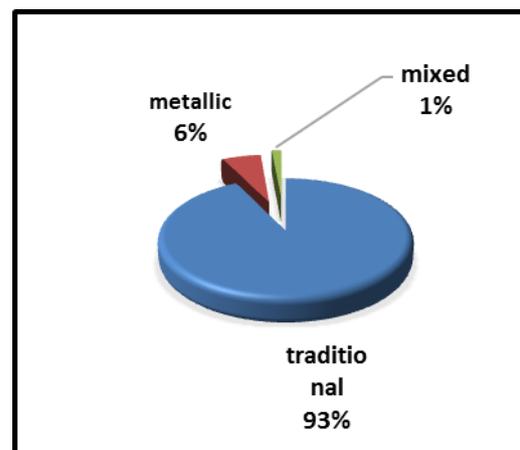
Figure 4. Types of framework

Figure 4 reports the types of framework that can be found on the buildings of secondary and primary school establishments in the city of Yaoundé visited. It appears that most of the frames, namely 93% are traditionally made, 6% are made of metallic materials and 1% of mixed materials.

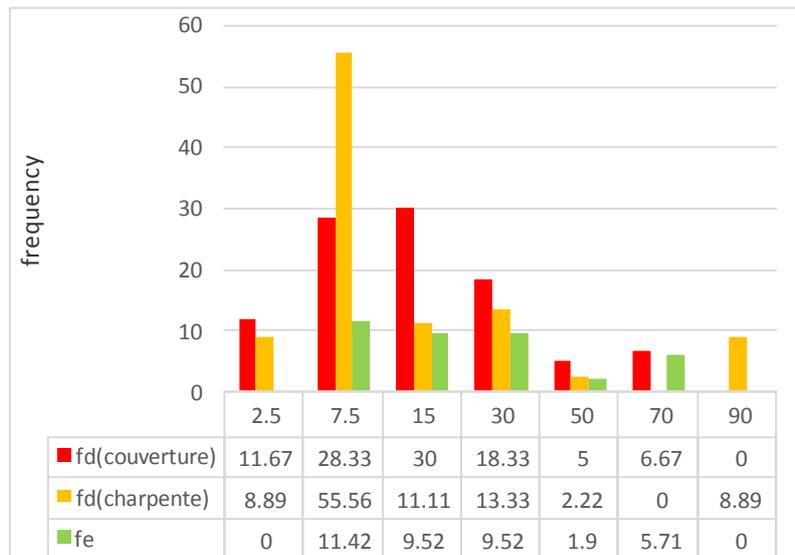
Figure 5. Frequencies of degradation (fd) and maintenance (fe) of the roofs and trusses/frames

Figure 5 reports the frequencies of degradations (fd) and maintenance (fe) of the roofs and trusses/frames of the buildings of secondary and primary school establishments in the city of Yaoundé visited. We can see that the degradation of the frame has a frequency of 55.56 of center 7.5. This is the consequence of the deterioration of the covers in the same center. It also shows that maintenance only takes place when the building is seriously degraded and working and study conditions are impossible.

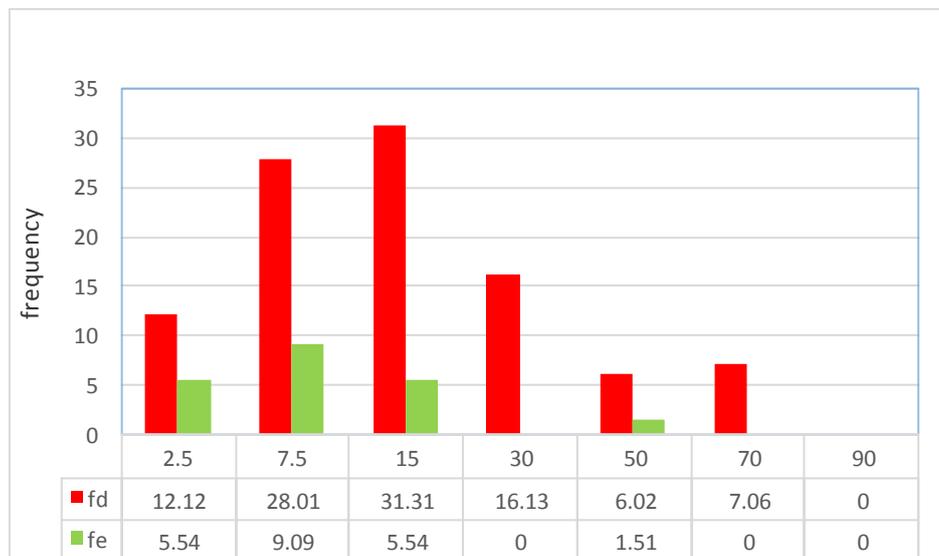
Figure 6. Frequencies of degradations and maintenance of the interior walls

Figure 6 shows that in center 15 the degradation frequency (fd) is 31.31 and the maximum maintenance frequency (fe) is 9.09 in center 7.5; this shows the poor condition of the paint on the interior walls of most of the classrooms.

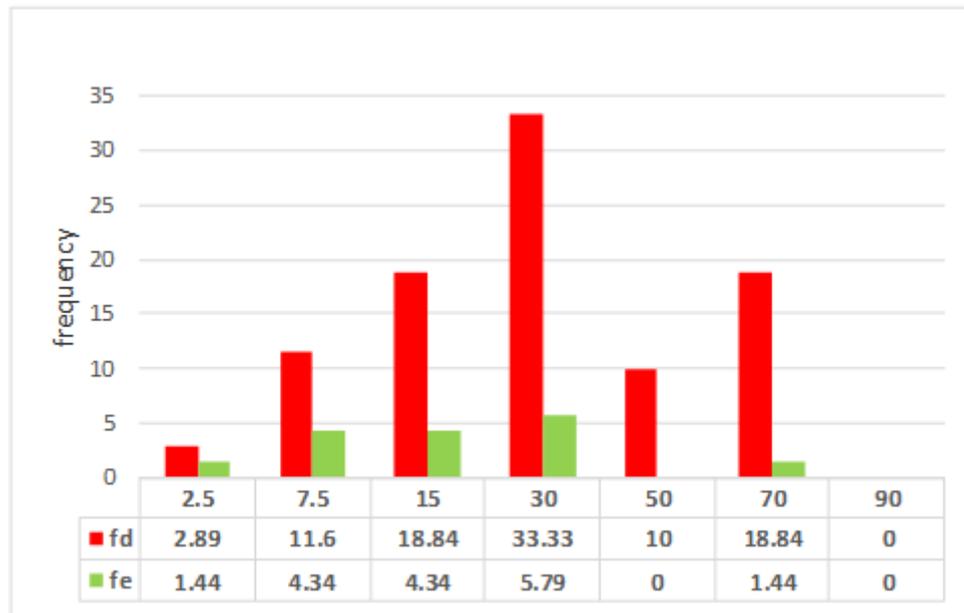
Figure 7. Frequencies of degradations and maintenance of the exterior walls

Compared to the interior, the exterior walls are more degraded, judging by the very high frequency of degradation (fd) (33.33) (Figure 7) for very low maintenance (fe) (5.79) (Figure 7).

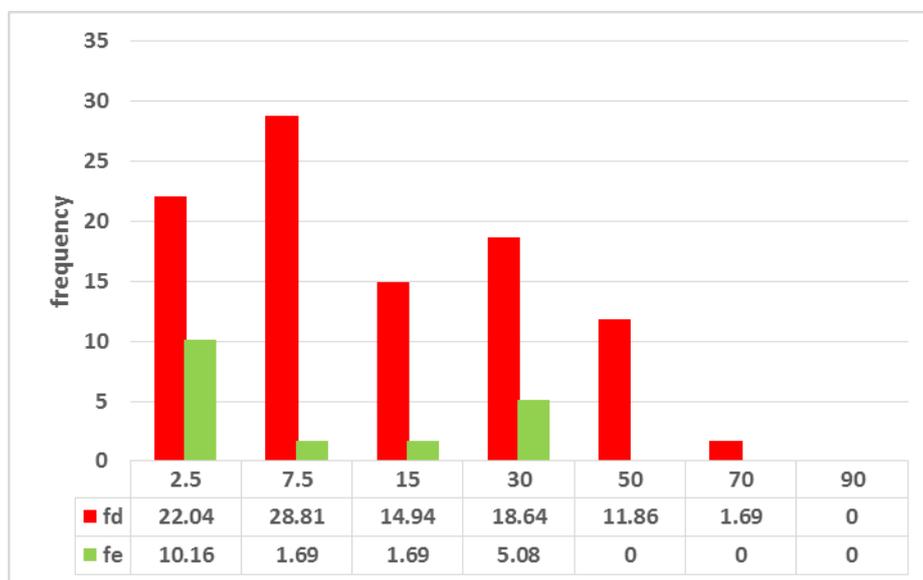
Figure 8. Frequencies of degradations and maintenance of the cracks in the walls

Figure 8 shows that the cracks in the walls have a frequency of 28.81 in the center 7.5 with a consequent maintenance frequency of 1.69. Overall, the degradation is decreasing and the maintenance measures do not always follow.

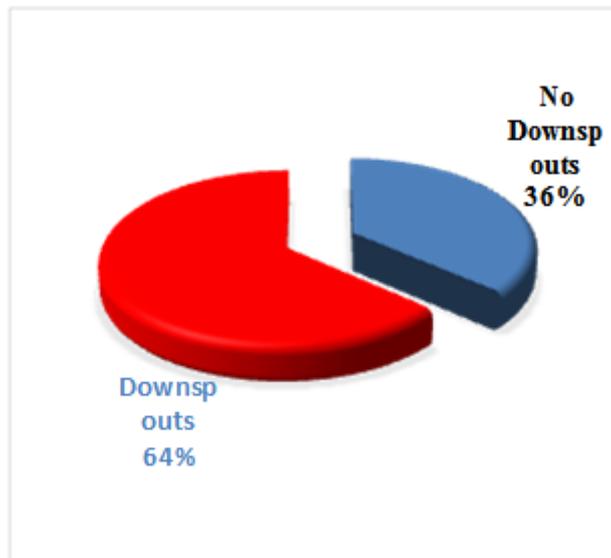
Figure 9. Downspouts

Figure 9 shows that for all of the buildings surveyed, 64% have downspouts compared to 36%; good reason to explain the recurring problems of deterioration in exterior walls and ceilings.

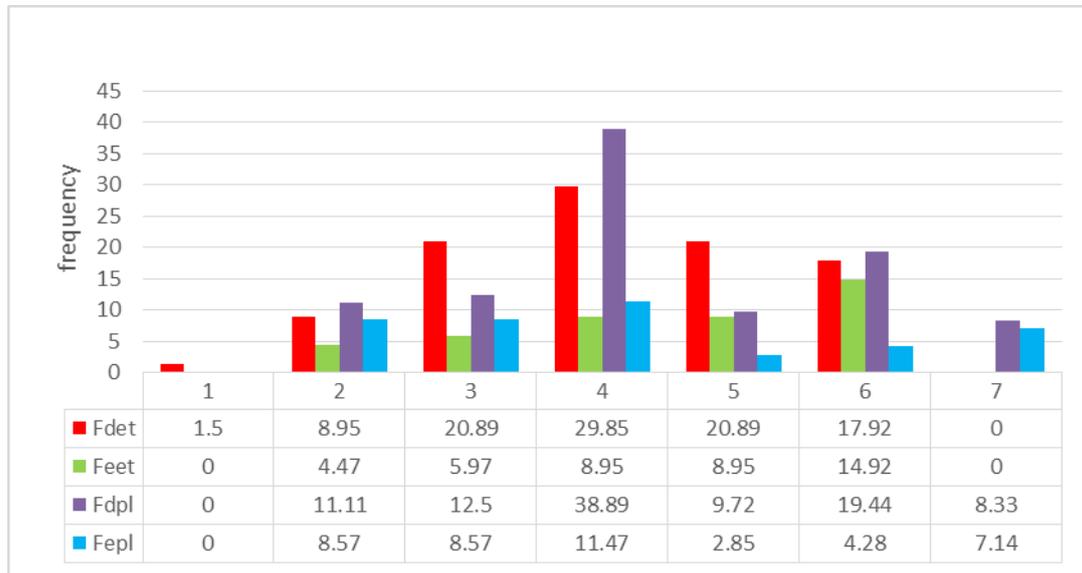
Figure 10. Frequencies of degradations and maintenance of the toilets, plumbing

Figure 10 shows that the degradations of the toilets reaches 29.85 in frequency and that of the plumbing reaches 38.89 in the 4th class with respective maximum maintenance frequencies of 17.92 in the 6th class and 11.47 in the 4th class. This is explained by the fact of the perpetual and almost permanent state of dirtiness of the toilets affecting the plumbing thus leading to the regular abandonment of the students' toilets in most of the establishments visited.

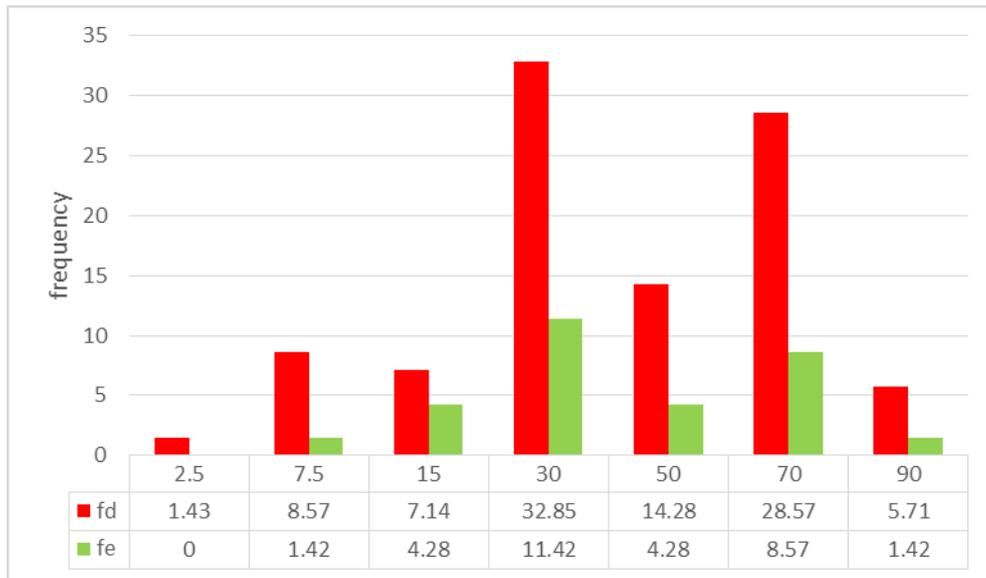
Figure 11. Frequencies of degradations and maintenance on the electrical elements

Figure 11 shows the degradations (fd) and maintenance (fe) frequencies on the electrical elements of the buildings of secondary and primary school establishments in the city of Yaoundé visited. From this figure 12, we can see that in amplitude 30 the degradation is 32.85; with that of maintenance at 11.42 in the same amplitude.

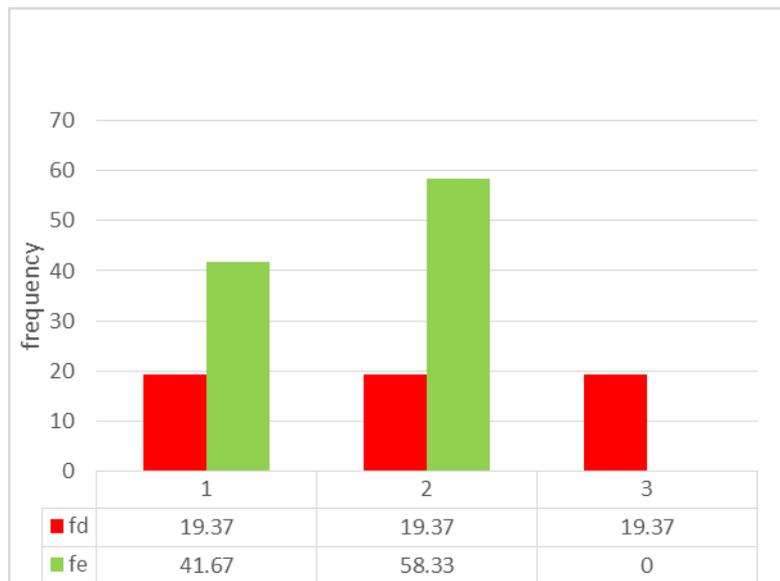
Figure 12. Frequencies of degradations and maintenance of the doors

Figure 12 shows that for most establishments, the degradation has an average frequency of 19.37 for the doors, and maintenance occurs very often after observation; this seems to be explained by the regular replacement of the locks and hinges when the latter fail, in order to better contain the educables.

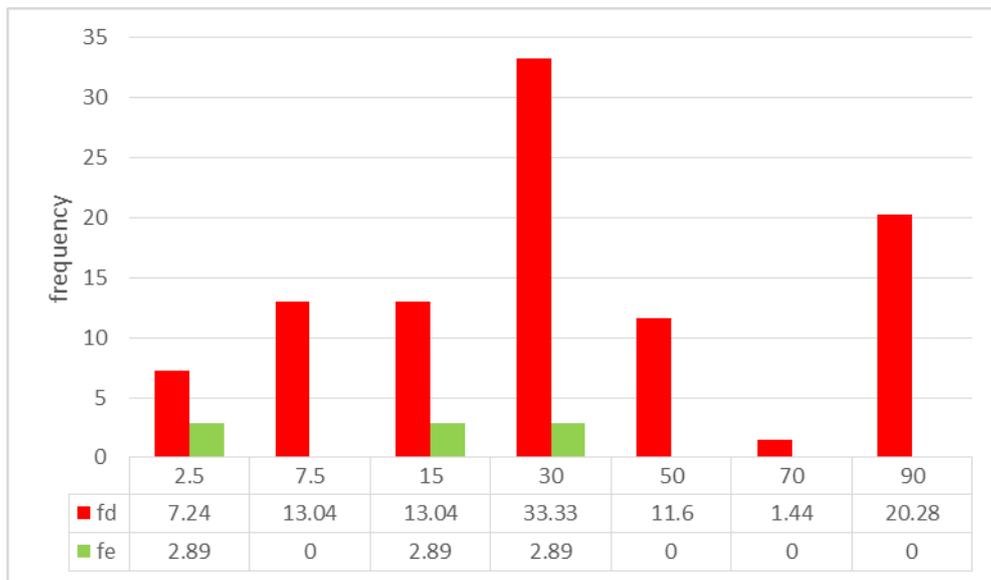
Figure 13. Frequencies of degradations (fd) and maintenance (fe) of the fences

Figure 13 reports the frequency of degradation (fd) and maintenance (fe) of the fences of the buildings of the secondary and primary school establishments in the city of Yaoundé visited. From this figure 13, we can see that in the amplitude 30 the degradation is 33.33; and that in most establishments the fences are in a state of disrepair without any maintenance measures being considered.

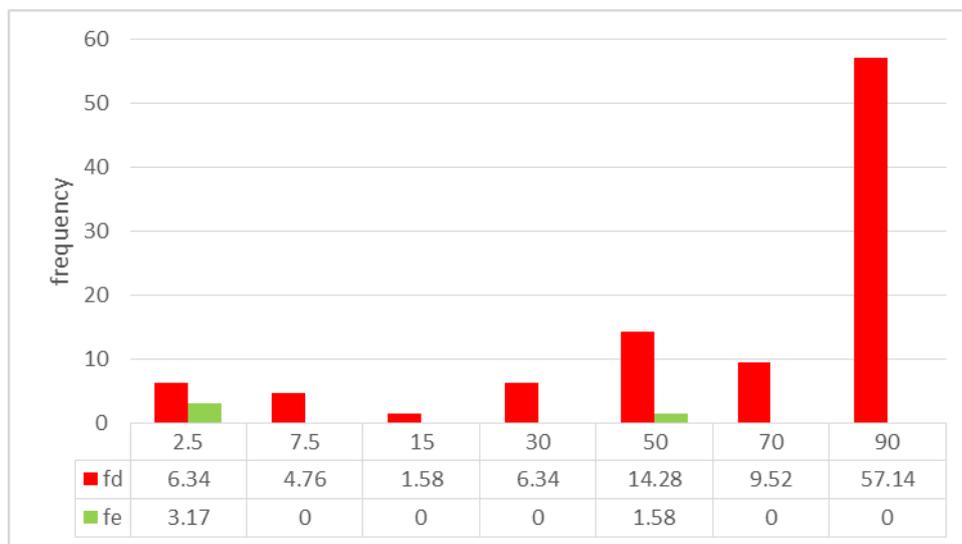
Figure 14. Frequencies of degradations and maintenance of the VRDs (Road and various networks)

The state of degradation illustrated in Figure 14 attests that in most schools in the capital city, the VRDs (Road and various networks) are not part of the habits of those in charge and even if they exist, maintenance does not always follow.

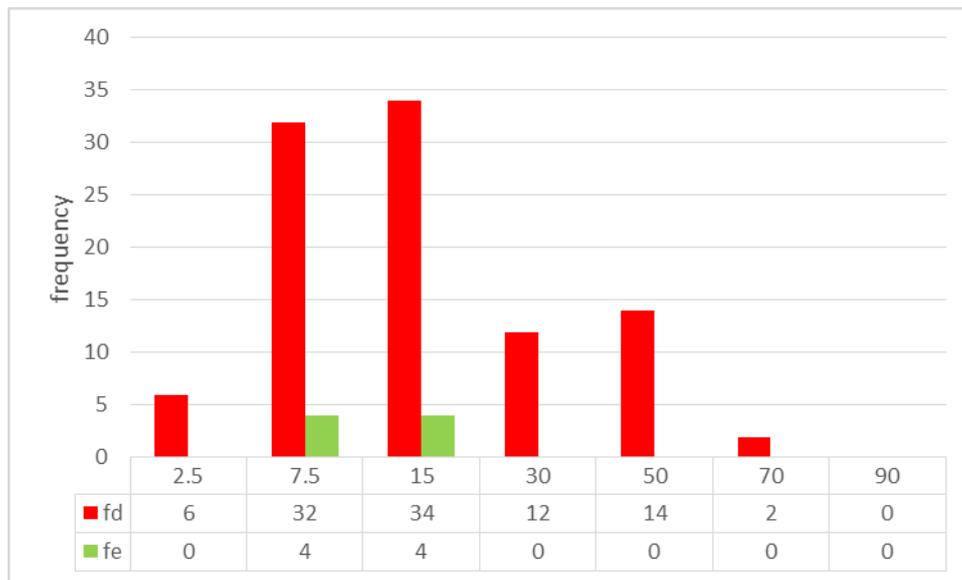
Figure 15. Frequencies of degradations and maintenance of the interior ceilings

Figure 15 shows that the degradations of the ceilings culminate at 34 in terms of frequencies for the interior and to 40.9 (Figure 16) for the exterior of respective amplitudes 15 and 30; with almost non-existent maintenance; proof the torn off, spotted ceilings do not seem to attract anyone's attention. This probably proves that the exterior appearance of a building does not always tell us about its interior condition.

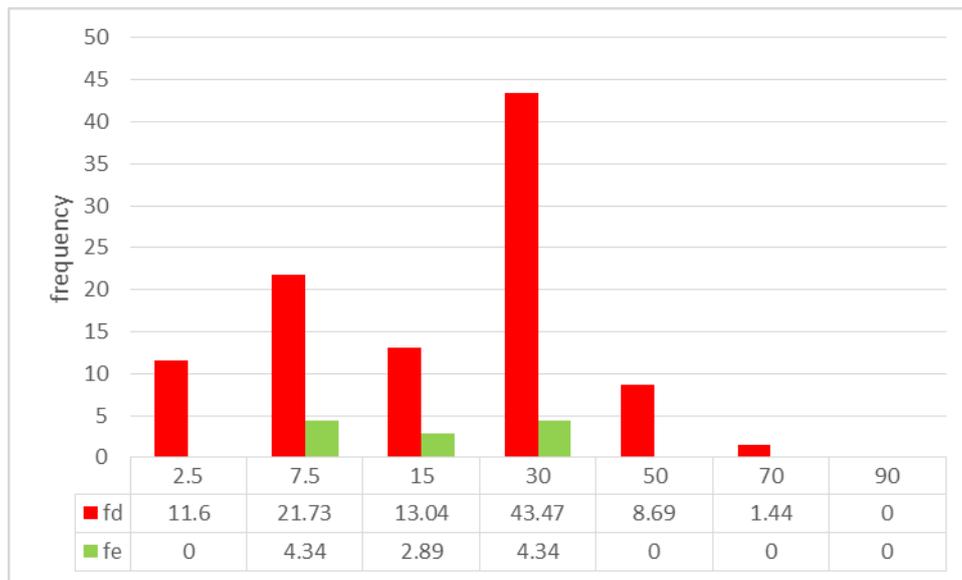
Figure 17. Frequencies of degradations and maintenance of the floors

The degradation of the floors of school buildings (mostly coated with slip) is at 43.47 frequency (Figure 17) in amplitude 30 with almost no maintenance overall, it seems that during construction work technicians have not respected the dosages of materials because even young buildings also know this phenomenon and the overcrowding of students is also for something.

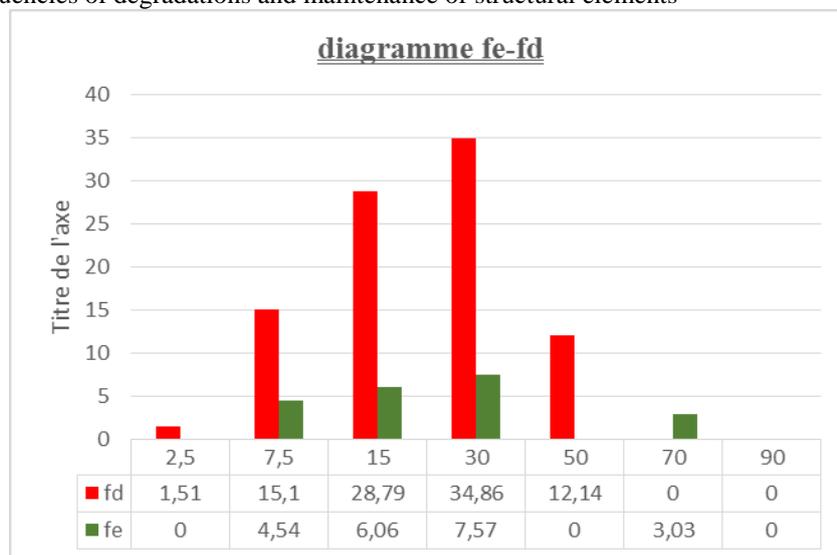
Figure 18. Frequencies of degradations and maintenance of structural elements

Figure 18 shows that the structural degradation frequency is very strong (34.86) of amplitude 30 with that of the maintenance at 7.57 in the same amplitude; Hence the old overall appearance of the buildings which were the subject of our investigations because of lack of maintenance. The observer will have the impression that these buildings were constructed during the colonial era.

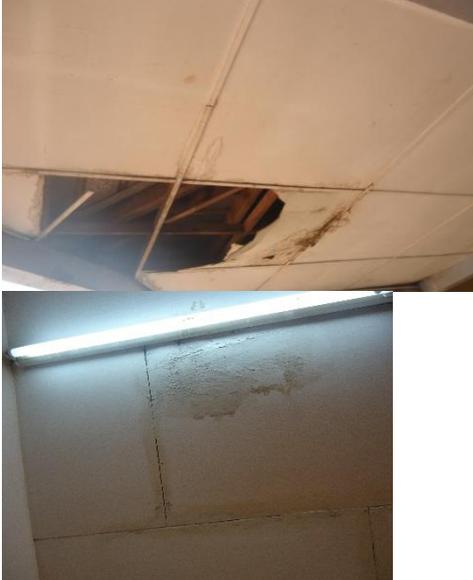
Torn off ceiling	The state of this ceiling is the result of repeated infiltration of rainwater
<ul style="list-style-type: none"> Roof and frame

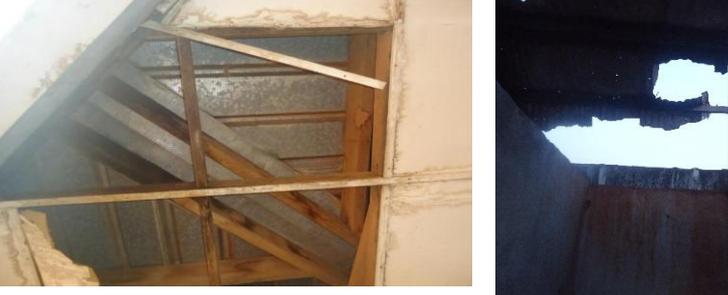
Roof torn off	The wind action and the lightness of the structure were right with this cover
<ul style="list-style-type: none"> Concrete window and electricity

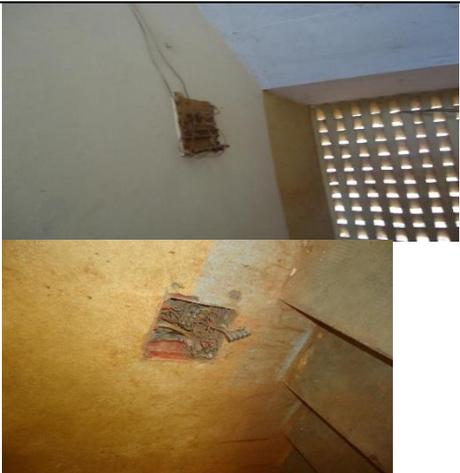
Box showing the malfunction of the electrical appliance	Empty case shows failure of maintenance-free electrical installation and vandalism

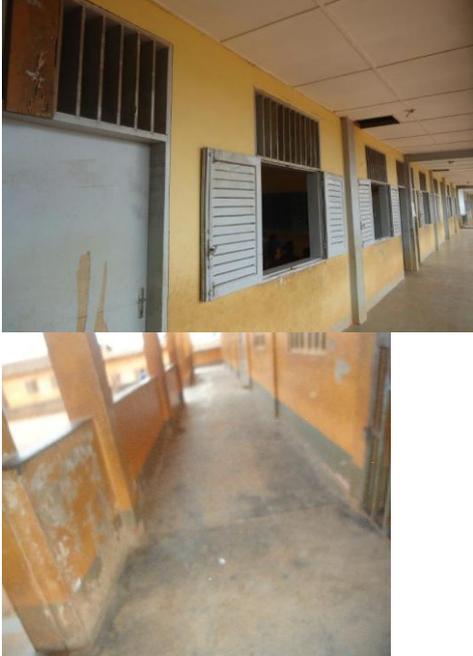
<p>Ceiling, window and exterior wall appearance in poor condition. It should be noted that the degradation of this wall is also caused by sporadic posters.</p>	<p>Flat iso door and degraded ceiling, this degradation is due to the current of humid air, and the lack of maintenance.</p>
<ul style="list-style-type: none"> • Toilet state

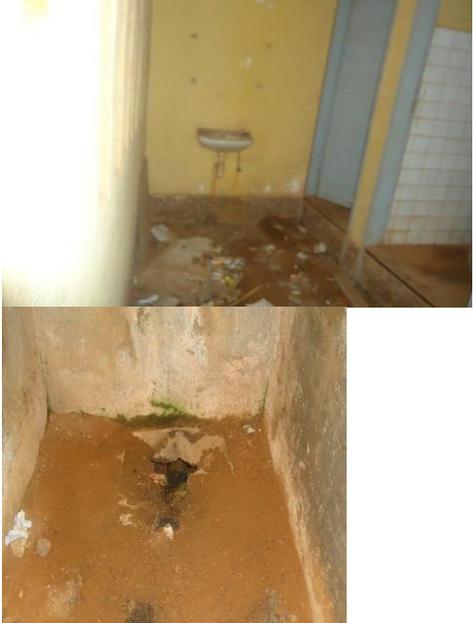
<p>Pitiful state of the toilets.</p>	<p>The lack of cleanliness of the toilets leads to this state of abandonment, due to the lack of water.</p>
<ul style="list-style-type: none"> • Toilet state with degraded door

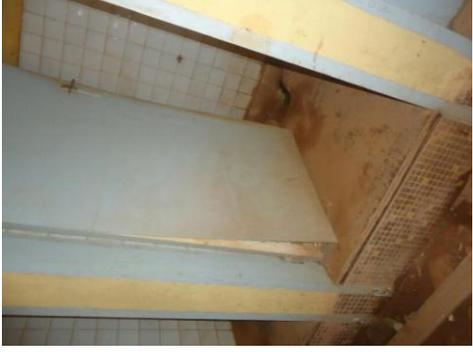
<p>Toilet without door.</p>	<p>Malfunction due to the absence of the door; vandalism or ultimate service.</p>

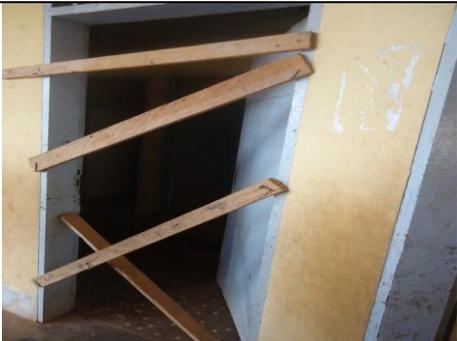
Toilet out of order	Toilet out of order due to lack of door
<ul style="list-style-type: none"> • Soil conditions

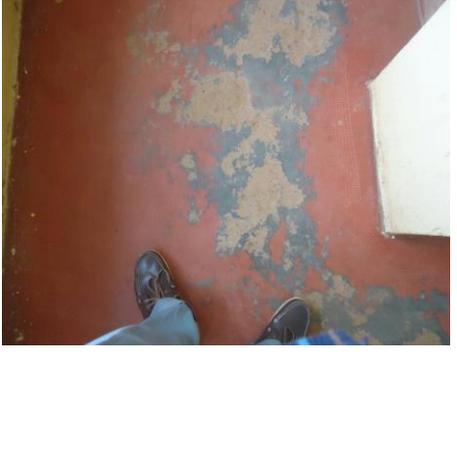
Soil degradation	Failure to comply with construction standards and disregard of the operating load caused this soil to degrade
<ul style="list-style-type: none"> • VRD (Road and various networks)

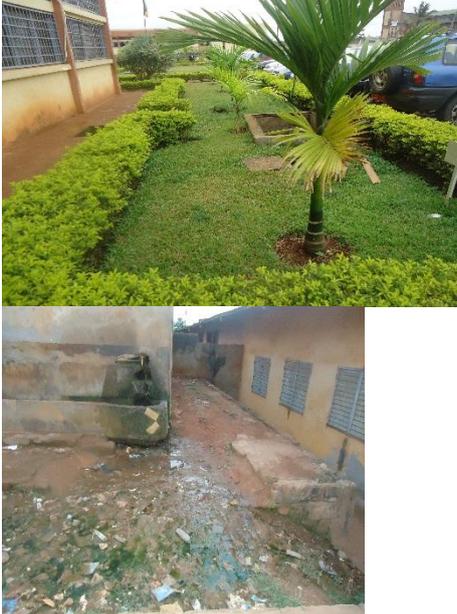
Road and various networks well maintained Road and various networks non-existent	The contrast between the Road and various networks of schools in the city of Yaoundé is very significant
<ul style="list-style-type: none"> • Fencing

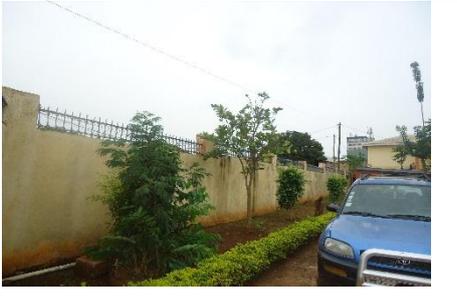
Fence in good condition	The condition of this fence shows its good construction and the regularity of its

maintenanc e
<ul style="list-style-type: none"> • Major works

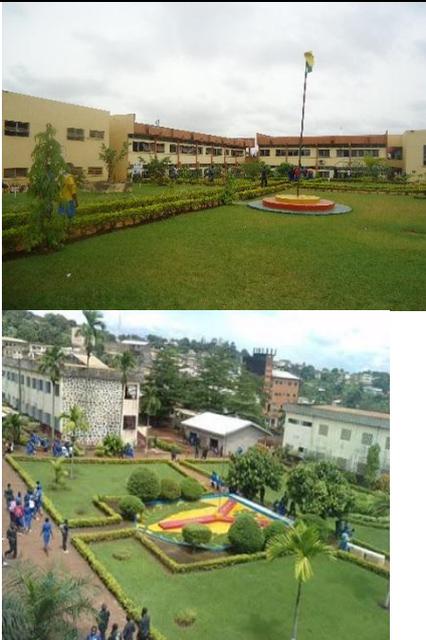
Ideal shell appearance	This establishment is the only one which displays a proud appearance
