# Tensile and Fracture Properties of Hybrid Date Palm Fibre Composite Structures Embedded with Chopped Rubber

Composites reinforced with natural fibres have been booming in recent years due to their health benefits and environmental friendliness. Today, date palm is particularly attractive in the Middle East region because it is widely available, cheap, and abundant. Date palm has been used in many simple industries since ancient times, for example, in the manufacture of rope. In the present study, date palms were used to reinforce epoxy resin with embedded rubber segments or crushed to use them for industrial applications. First, date palms are chemically treated in three different ways. The fibres are immersed in three different types of chemical solutions (CH<sub>3</sub>COOH, HCl and alkaline NaOH with three different concentrations of 10%, 20% and 50%) at boiling temperature for 1 and 2 hours. These fibres are then mechanically crushed into small fibre crisps. These fibres are mixed with epoxy resin in which 5% by weight of the rubber segments are embedded. The effects of the chemical treatment of the date palm fibres are analysed using electro-scan microstructure examination

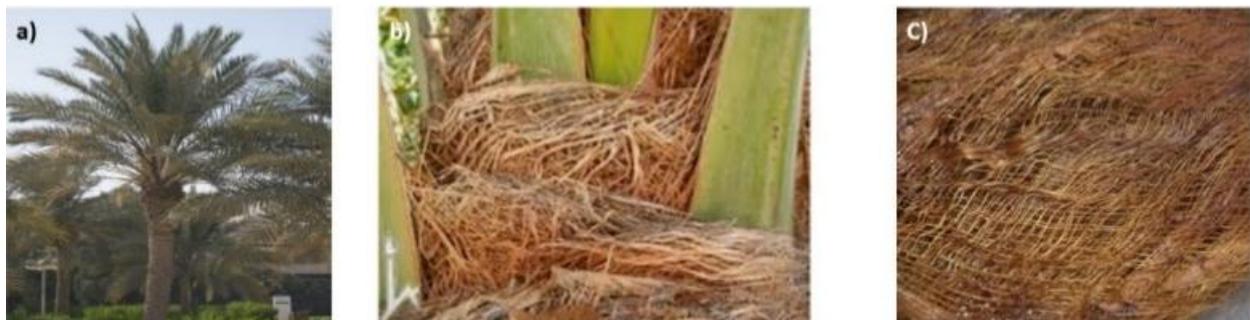
Figure 1. Photograph of a) date palm tree b) stems surrounding by fiber c) fibers [1, 2].

The date palm fibers (Figure 1) enclosing the stems were obtained from the city of Qena in Upper Egypt and have the physical and mechanical parameters shown in Tables 1 and 2. First, the fibers were cleaned from dust in a water bath and then dried at room temperature. They were physically separated into new fiber bundles, then wiped and dried at room temperature for 24 hours as shown in Figure (2- a,b). Electrical mixing is used to chop the fibers into small pieces for 15 minutes (Figure 2-c, d).

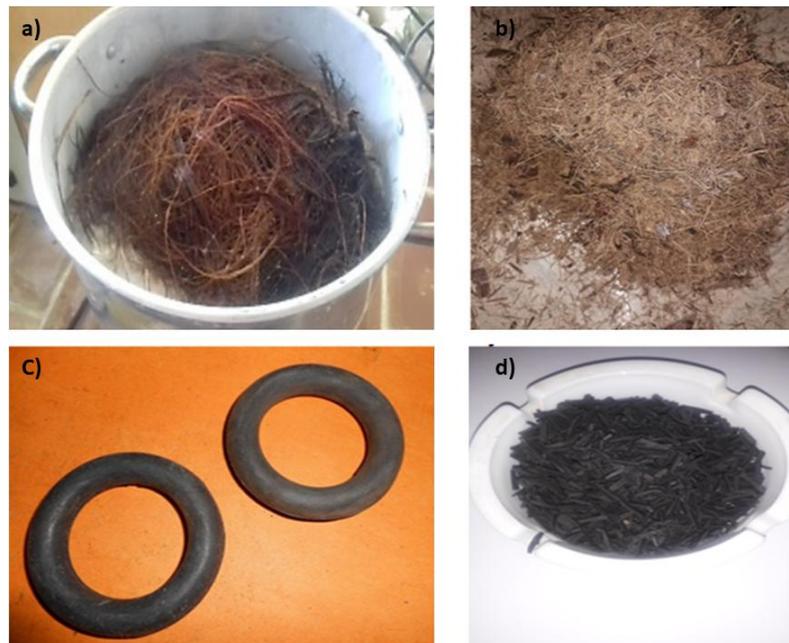
Figure 2 Renifircement phase a) Fiber bundles; b) Chopped Fibers; c) Rubber from car tires; d) Cut rubber
