Documentation for Restoration of a Heritage Educational Monument: A Case Study

This study aims to prepare such documentation for future restoration of a heritage educational monument using it as a case study. The monument selected in this study is India's third oldest engineering college, "College of Engineering, Pune (Maharashtra)". The College of Engineering Pune is 167 years old educational monument constructed in 1854 under the British regime using naturally available basalt stones.

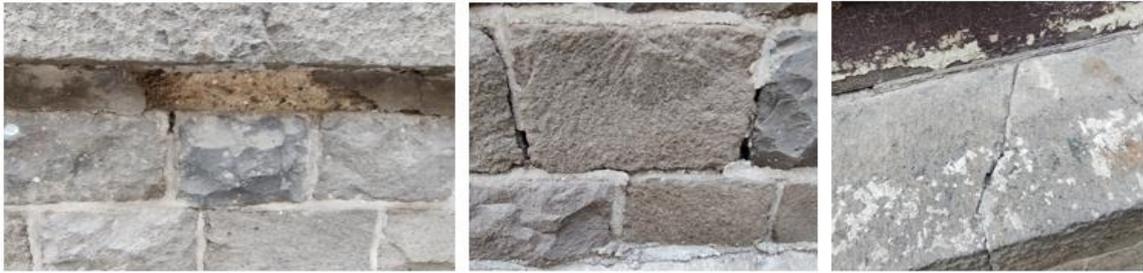
Fig. 9: Close-range photography of Civil Engineering Building

Engineering building was collected. Figures 9 and 10 represent digital photography of the Civil Engineering building, Figure 9 represents close-range photography, and Figure 10 represents long-range photography.

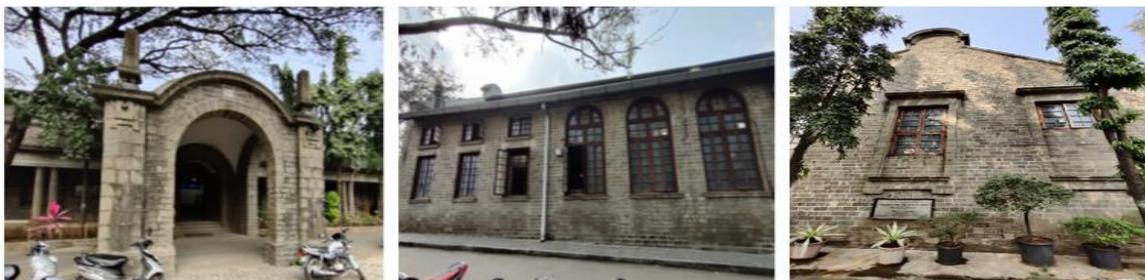
Fig. 11: Long-range photography of Mechanical Engineering building

photography of the Mechanical Engineering building, where Figure 11 represents long-range photography, and Figure 12 represents close-range photography.
