Low Velocity Impact Studies on Synthetic and Bio Fiber Reinforced Polyester Composites

Thyagaraj N R¹, N Chikkanna²

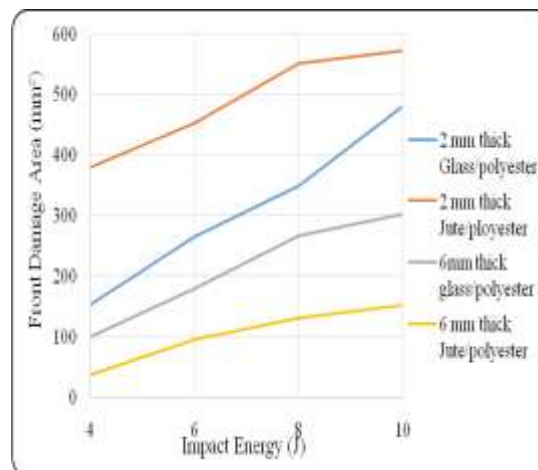
(a) Front face

Fig.2 Damage area of composites after drop weight impact

The test was conducted for impact energies for 4, 6, 8 and 10 Joules. After the test, damage area was measured and the results were plotted against impact energy as shown Fig.2 (a) and (b). The main parameter that plays a major role in damage is impact energy. The damage area was found maximum for 2 mm thick JFRP and it was completely broken. The Fig. 2(b) shows back surface

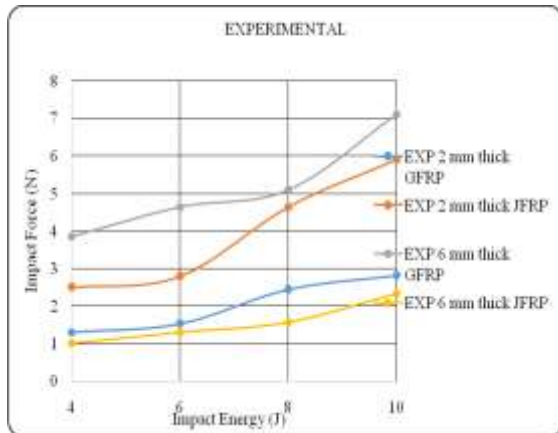
Fig.3 Impact force against impact energy

The impact force increases with increasing impact energy for all the specimens as shown in Fig.3. The glass fiber reinforced composites with variable thickness are more influencing on resistance to impact forces. The impact forces linearly increase with increasing impact energy. The glass fiber reinforced polymers have higher strength and hence it has higher resistance to impact forces.

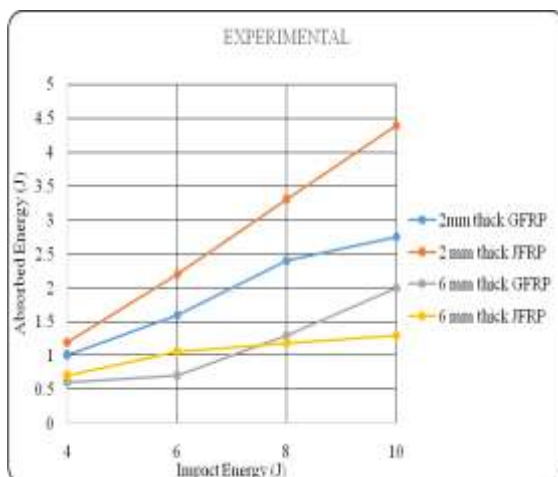
Fig.4 Effect of absorbed energy on different thickness and material

Fig. 4 shows the energy absorption against the impact energy level. The absorption energy is directly proportional to impact energy level in all type of specimens. Similar to previous results it is clear that the glass fiber reinforced specimens shows lower energy absorption and also more resistance to impact damages. The change in absorbed energy is

found more for 2 mm thick JFRP composite and it is clearly visible that the energy absorbed by the specimen increases as there is an increase in nominal impact energy.

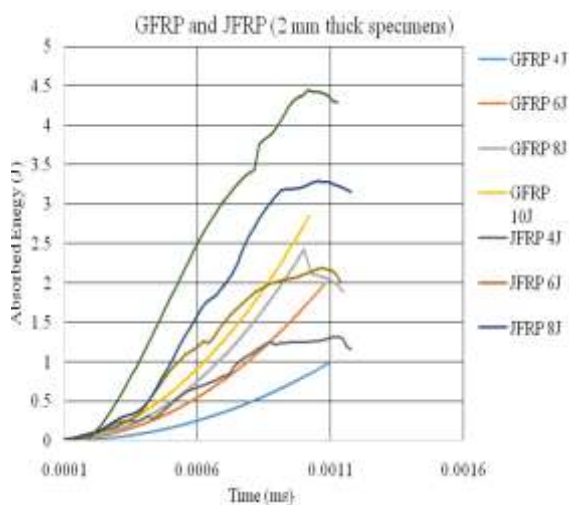
Fig.5 (a) Absorbed energy versus time

Due to increase in impact energy, the absorbed energy was found higher along the time as shown in Fig. 5(a). Higher the impact energy higher will be the absorbed energy irrespective of the materials. The absorbed energy and damage area was found lower in 6mm thick samples compared to 2 mm thick composite samples. The GFRP composite absorbed 2J of energy under the impact energy of 10J which resulted in the delamination between the layers and it can be observed in Fig. 5(b).

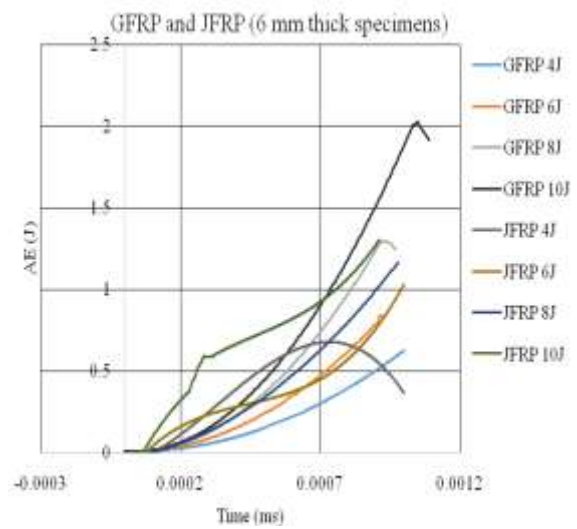
Fig.5 (b) Absorbed energy versus time
