## Seismic Vulnerability and Mitigation on Non-Engineered Traditional Buildings of Bhutan

**Abstract:** Earthquake is one of the most deadly phenomena which disturb the harmonious living among human beings and claimed large number of lives without any notice and warning. However one should always be ready to learn, how to live with seismic hazard and minimize its adverse effect on built environment, as its happening can't be prevented. The 6.1 magnitude Earthquake of 21<sup>st</sup> September, 2009 caused huge damage in the eastern part of Bhutan and adjoining areas like Indian states and Bangladesh. This incident has now exposed to the seismic vulnerability and raised concerns over the safety of the built environment in Bhutan – particularly, the traditional stone and timber houses, some of which were badly affected during the earthquake. This paper presents an overview of damages observed in the region and its causes and performances of building during earthquake. It also describes, the seismic performance of those structures can be improved from life safety point of view, by adopting simple low-cost modifications to the existing construction practices and material selection wit

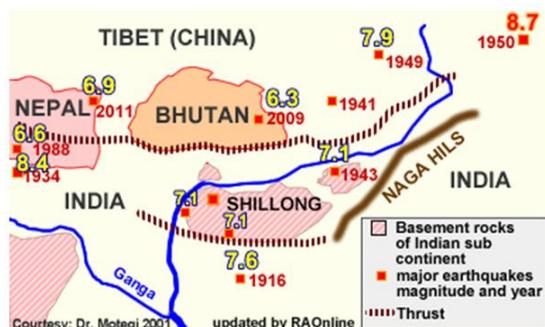
Figure 3: Earthquakes in and around Bhutan (Motegi, 2001)

The first recorded earthquake was reported in 1713 which was believed to have occurred in the Eastern Bhutan near Arunachal Pradesh (Bilham, 2004). It was reported to occurred in the night of spring with heavy casualties to human lives and build environments, though its exact time, size and location of epicenter was not specified exactly. Among 32 earthquakes occurred in and around last seven decades, the earthquake of magnitude 6.75 in 1941 was most notable in Bhutanese history (Dorji, 2009). According to Walling and Mohanty (2009), following list of earthquake has hit Bhutan; Mw=8.7 Shillong Plateau in 1897, Mw=8.3 Bihar-Nepal border in 1934, Mw=7.7 Assam in 1947 and Mw=8.6 Arunachal Pradesh in 1950. Figure 3, shows the earthquake occurred in and around Bhutan.

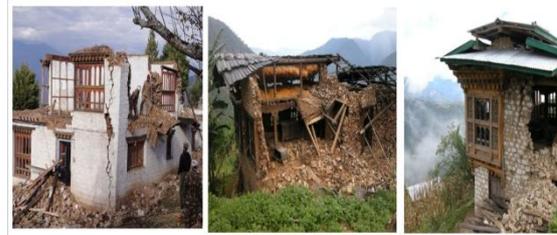
Figure 7a, 7b & 7c: Traditional house in Eastern Bhutan heavily damaged by 2009 earthquake. Photo: Rohit Jigyasu, Bank

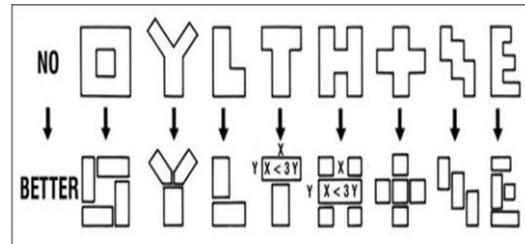
Figure 8: Simple plan performs well during earthquake. Source: <http://www.earth-auroville.com>

C.V.R Murty in his Earthquake tips states that, size of the building plays vital role in safety measures. Longer building has more damaging effects. Simple layout of buildings provide better performance than building of C,U,L and cross shaped buildings. For example, to have efficient

performance, complex shaped buildings are broken into two or more rectangular layouts, as shown in figure 8.

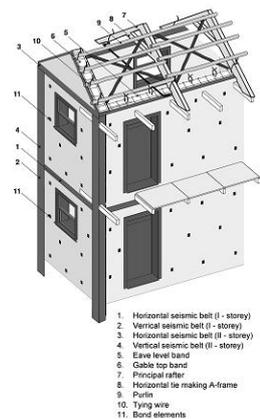
1. Horizontal seismic belt (I - storey)
2. Vertical seismic belt (I - storey)
3. Horizontal seismic belt (II - storey)
4. Vertical seismic belt (II - storey)
5. Eave level band
6. Gable top band
7. Principal rafter
8. Horizontal tie making A-frame
9. Purlin
10. Tying wire
11. Bond elements

Figure 11: Overall arrangement of reinforcing masonry buildings, Source: A.S.Arya

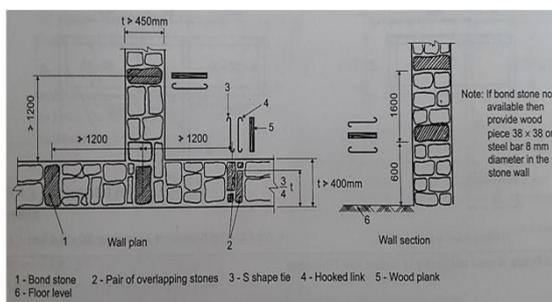
Figure 12: Through stones or Headers for integrity of stone walls, Source: IAEE

4. The openings should be recommended to be minimum, small and centrally located as shown in figure 10.
5. To increase the strength of wall, usage of clay mortar should be minimized and it is preferred to have cement mortar mix of 1:6.
6. In random rubble masonry, the courses should not be lifted more than 600mm for its stability.
7. For horizontal binding, Murty states that, a building should have roof bands, lintel bands and plinth bands with cross wall connections as in figure 11. Providing bond beams can achieve better integration of roof and wall.
8. To integrate the Wythe of walls together, through stone of length, which is equal to wall thickness should be provided in every 600mm lift and 1200mm apart horizontally. Well-seasoned wood bars of 38mm x 38mm can be also used as through stones as shown in figure 12.

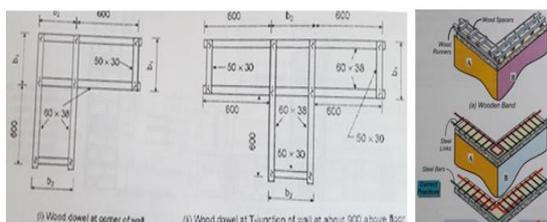
Figure 13a & 13b: Details of wood and steel reinforcing at corners and T-junctions Source: IAEE

9. The connection of perpendicular walls (T and L junctions) to enhance building integrity can be performed by tying the walls together using wooden frames as shown in figure 13. It can also do by materials having higher tensile strength and ductility. It includes: (i) wire mesh reinforcing (ii) use of polypropylene bands (iii) use of corner stitches (L and T-stitch) made of reinforced concrete as shown in figure 14&15.

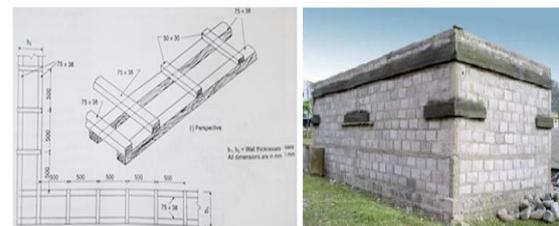
Figure 14: Lintel level wooden band on all load bearing walls, Source: IAEE
